# INVESTIGATION REPORT

**REPORT No. 01/08/2022**

**FINAL REPORT OF AN ACCIDENT INVOLVING AN  
AIRBUS AS 350 B3E HELICOPTER REGISTRATION  
5Y-CCP ON 04 AUGUST 2022 AT LAKE LOGIPI,  
TURKANA COUNTY**

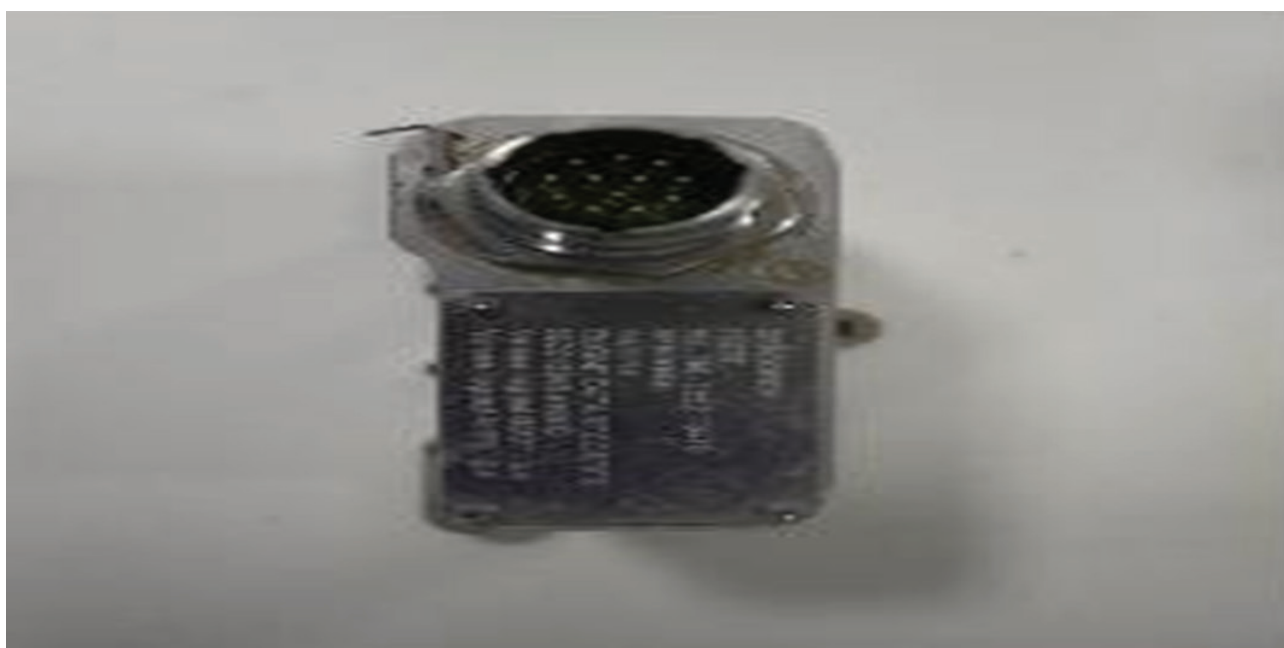
A visual inspection of the EDR determined that, although the unit had been exposed to water, it remained in good physical condition. The recorder was subsequently opened, and its electronic board was examined under magnification. The board was found to be clean, intact, and free of any signs of moisture intrusion. Owing to the satisfactory condition of the device, a direct data extraction was carried out using the manufacturer's proprietary software. This process produced a raw data file, which was then converted using a dedicated Safran analysis tool supplied to the BEA-France.

**Figure 5:** A photograph showing the EDR

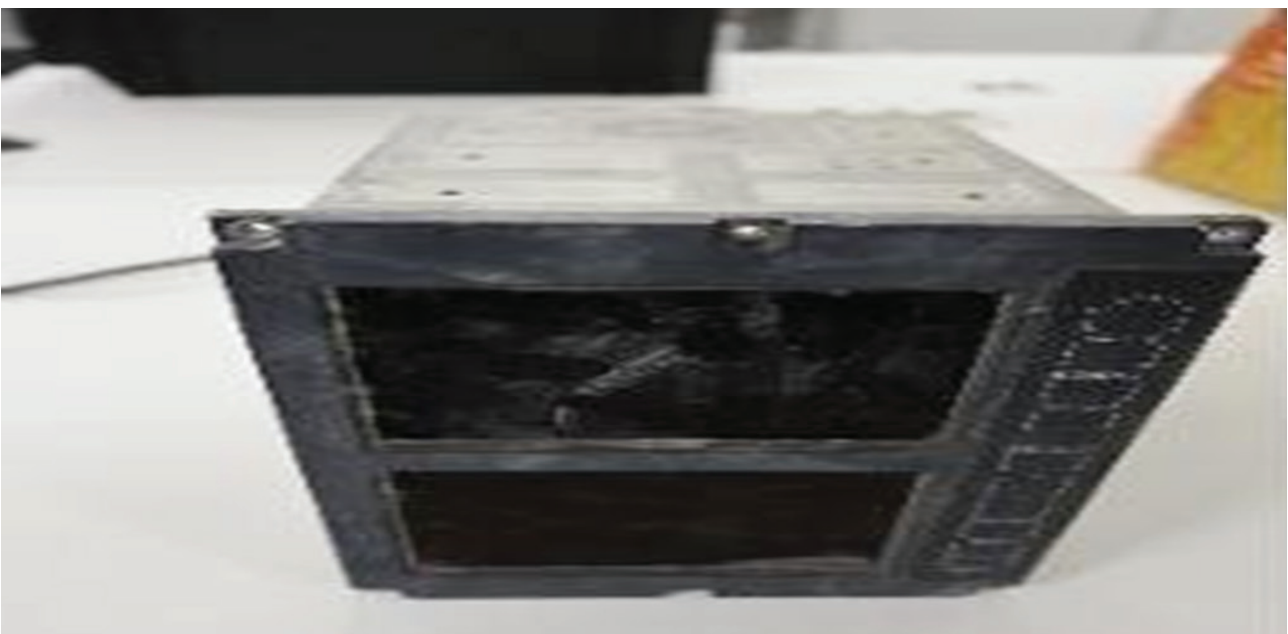
**Figure 7:** A photograph showing the VEMD

The VEMD underwent a visual examination and was found to be heavily corroded. The unit was subsequently opened, and the two internal electronic boards were removed and dried for more than 48 hours at a temperature of 90°C. However, because the EDR recording already contained the engine parameters from engine start-up through to the accident sequence, further work on the VEMD was deemed unnecessary, as it was not expected to provide any additional insight into the causes of the accident.

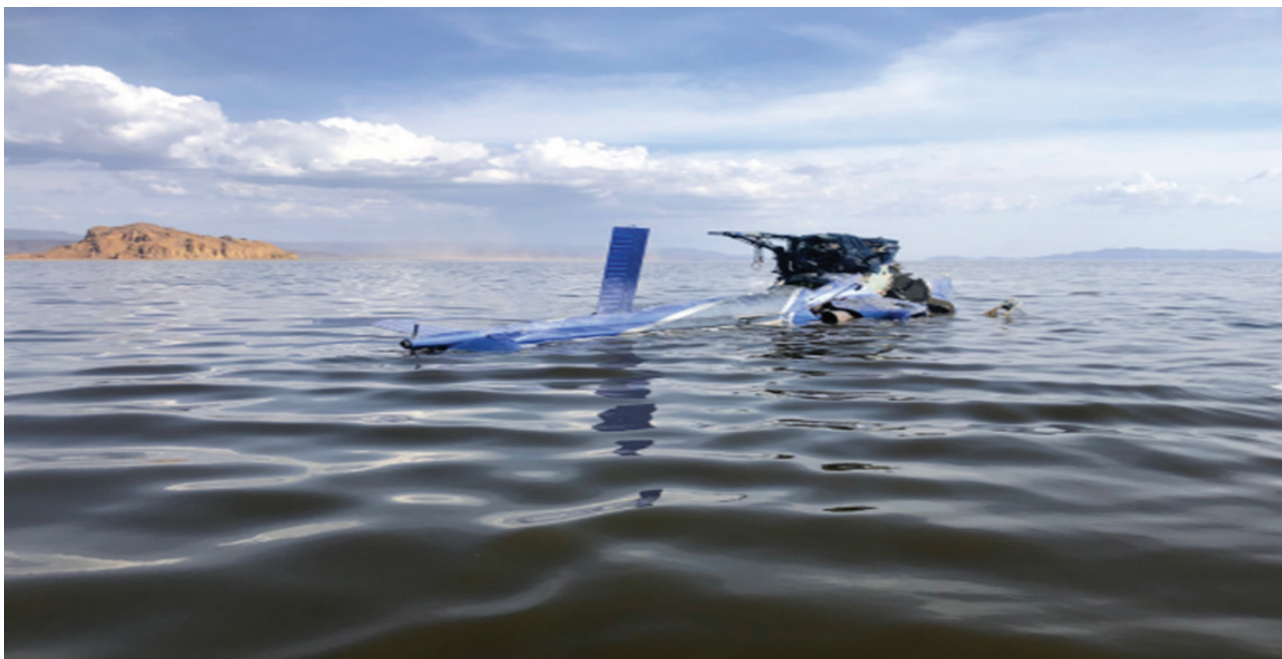
**Figure 8:** A photograph showing the topside of the aircraft partially submerged in water

The helicopter's main rotor blades impacted water first and the fuselage came to rest on its right side on the muddy lake bed in approximately 2 to 3 feet of water.

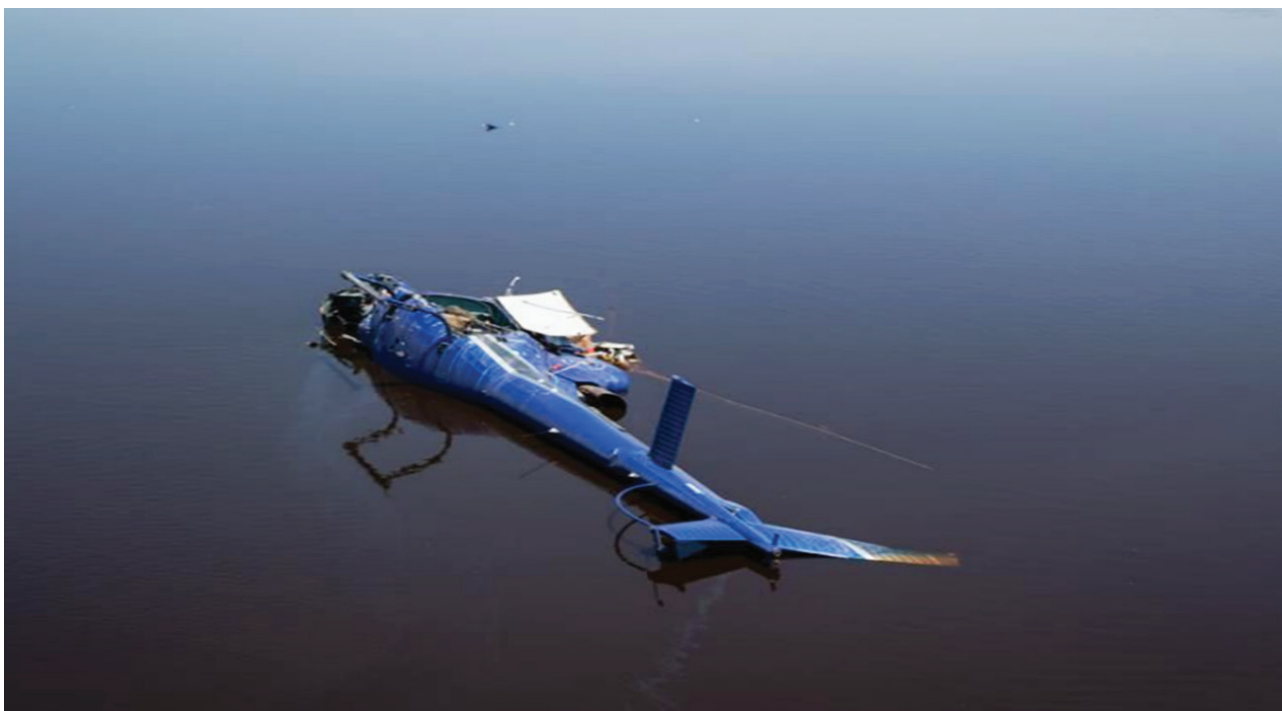
**Figure 9:** An aerial photograph showing the final resting point of the aircraft, half-submerged in water

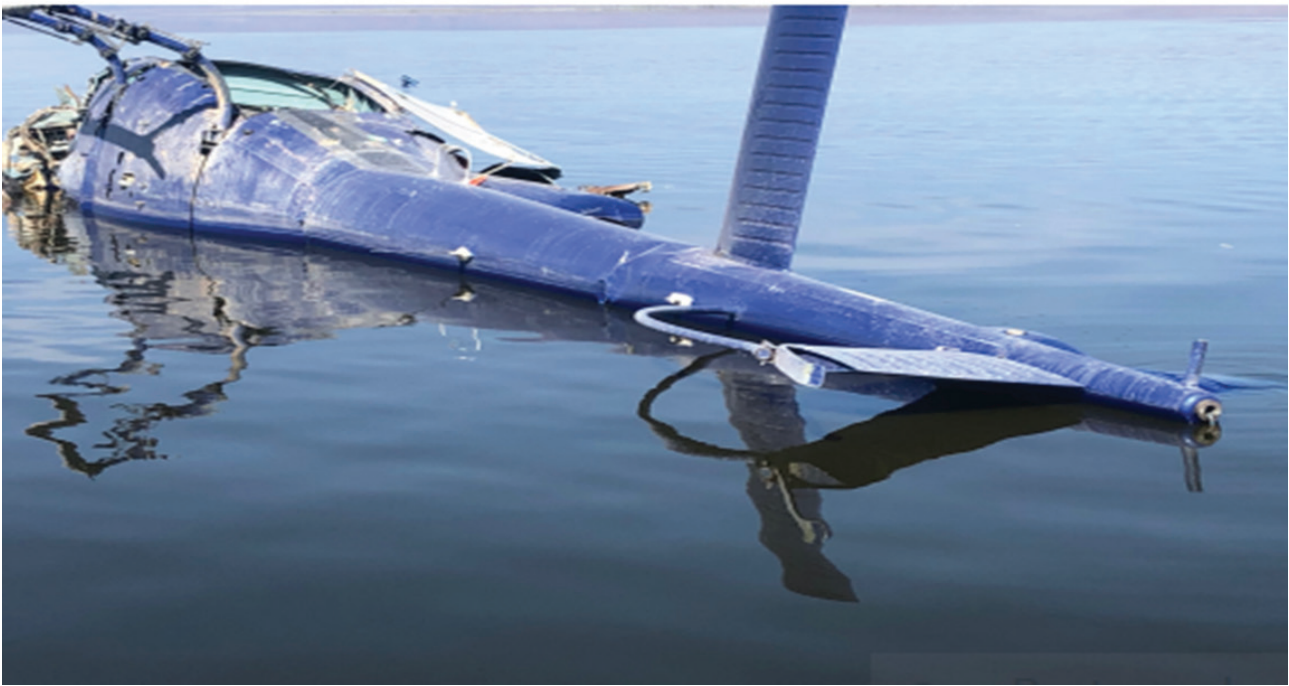
**Figure 10:** A Photograph showing the underside of the helicopter partially submerged in water

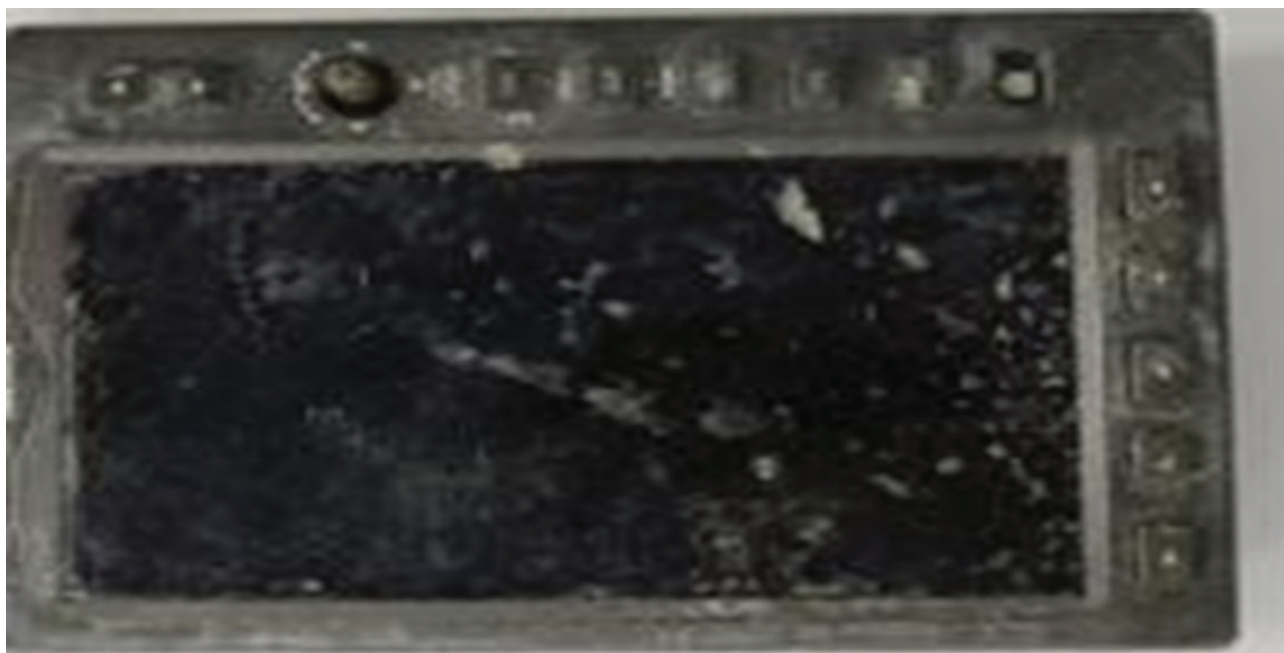
**Figure 11:** A photograph showing the GPSMAP 696

The unit was visually examined and found to be dirty, corroded, and missing several buttons. The electronic board was removed and was also observed to be heavily corroded. The main electronic board was dried for more than 48 hours at a temperature of 90°C. The memory component was then unsoldered using an infrared rework station under controlled temperature monitoring, after which it was cleaned and read out using the BEA memory reader. The relevant data area was identified, and a binary file titled 5Y-CCP-GPSMAP-Dump-
