**AIRCRAFT ACCIDENT INVESTIGATION DEPARTMENT**

**INVESTIGATION REPORT No. 01/06/2026**

**A PRELIMINARY INVESTIGATION REPORT OF A SERIOUS INCIDENT  
INVOLVING TBM 700C2 REGISTRATION 5Y- XCB, ON 01 JUNE 2026, AT  
LANDING OL KIOMBO MAASAI MARA AIRSTRIP, NAROK COUNTY, KENYA.**

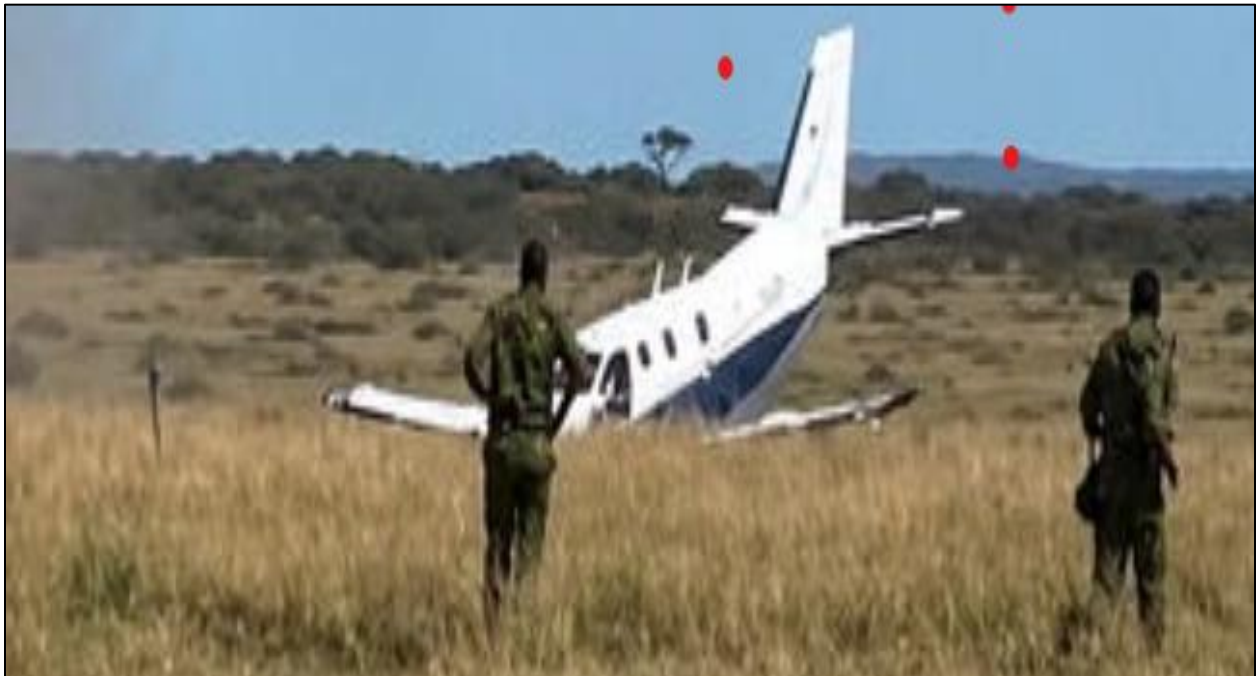
The aircraft flared and touched down on the main landing gear. The nose gear subsequently contacted the runway surface and, after rolling approximately 250m, struck a rock on the runway. The impact caused the nose landing gear to collapse into the wheel well. As the aircraft decelerated, the propeller contacted the hard-packed runway surface, resulting in significant damage. The asymmetric forces from the rotating propeller caused the aircraft to veer off to the right of the runway into a drainage ditch and tall grass before coming to rest on the forward fuselage and air intake.

**Fig. 2:** *Photo showing the accident aircraft at the final resting point immediately after runway excursion*

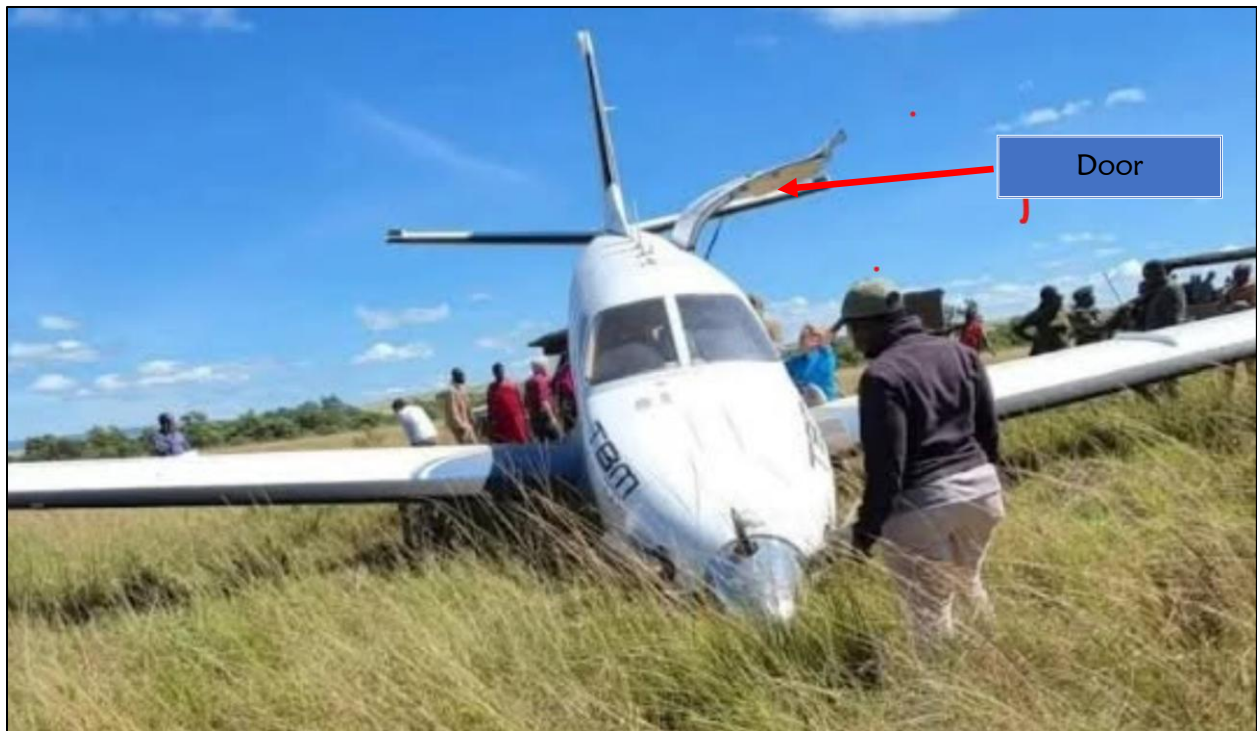
**Fig. 3:** *Photograph showing emergency response at the aircraft site*

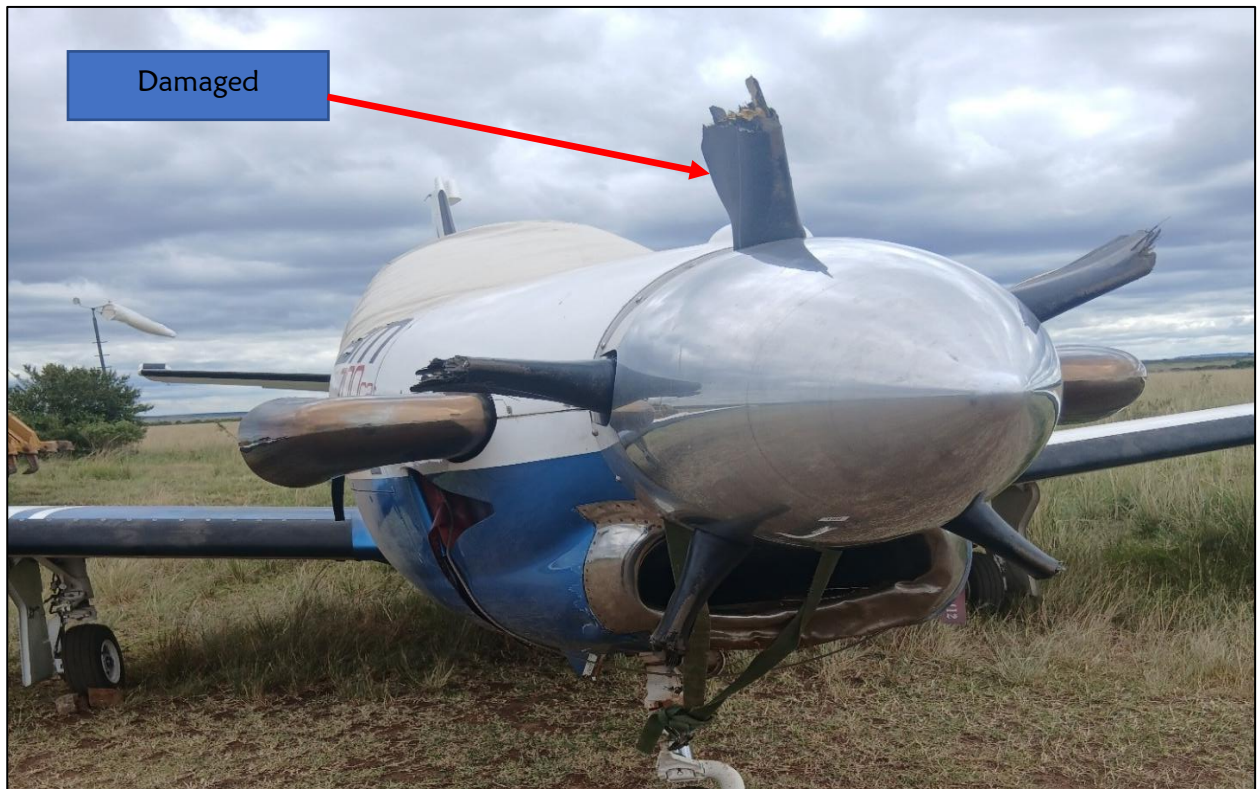
Upon landing, the nose landing gear collapsed, resulting in the propeller blades contacting the ground. The propeller blades fractured close to the hub, leaving only short stubs attached. The lower engine cowling sustained significant deformation and tearing, with additional impact damage observed around the air intake area beneath the spinner. The spinner remained largely intact and relatively symmetrical, and the propeller hub remained attached without complete disintegration. The nose landing gear was found collapsed and unsupported following recovery of the aircraft.

**Fig. 4:** *Photograph showing damaged blades of the accident aircraft at the apron.*

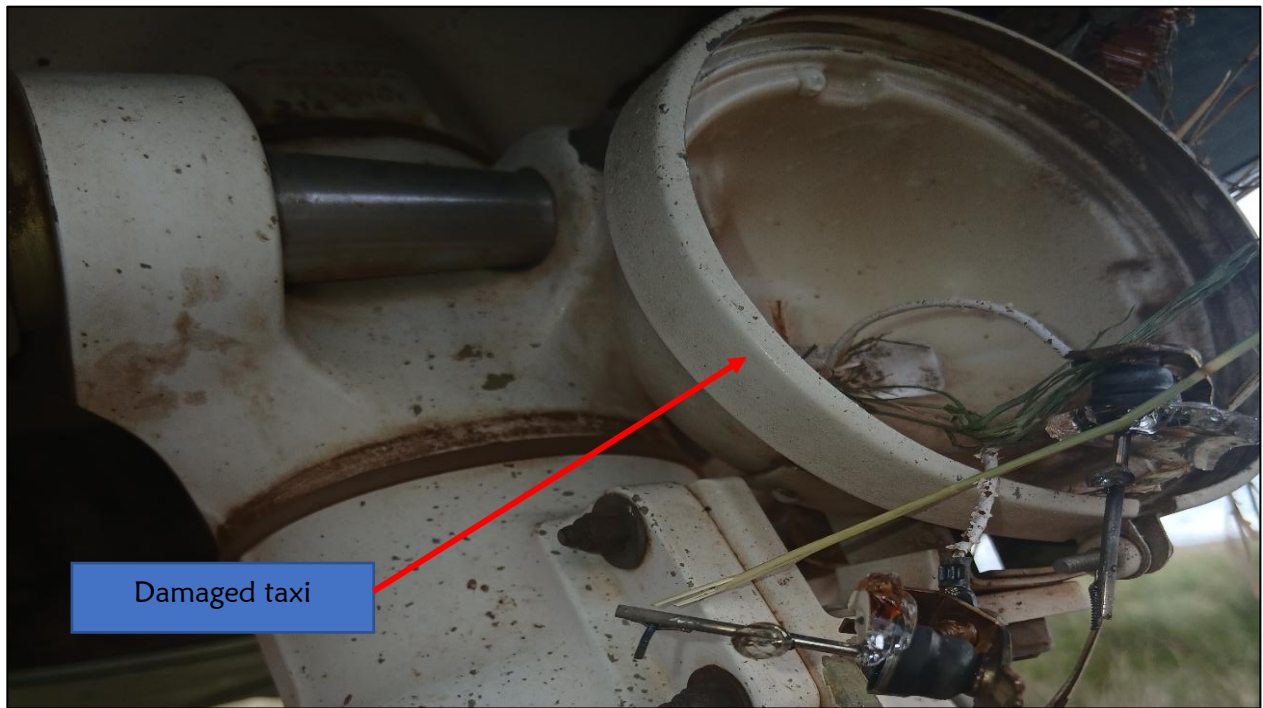
*Fig. 5: Photograph showing the damaged landing lights at the apron*
