**INVESTIGATION REPORT No. 01/04/2026**

**PRELIMINARY INVESTIGATION REPORT ON A RUNWAY INCURSION  
INCIDENT INVOLVING A PIPER PA-32 AIRCRAFT, REGISTRATION 5Y-BRJ, ON  
19 APRIL 2026 AT COULSON AIRSTRIP, GILGIL, NAKURU COUNTY, KENYA.**

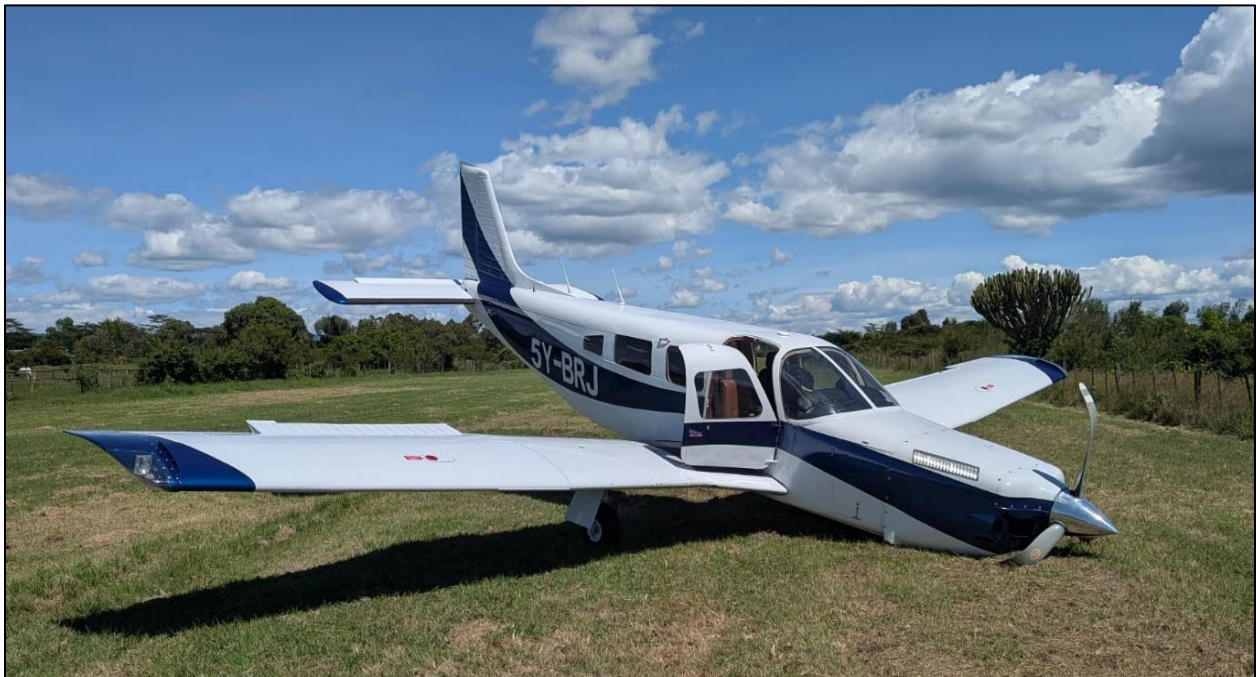
The aircraft came to a halt approximately 350 metres from the threshold on the left-hand side of the runway. The pilot then turned the fuel selector off, and both occupants exited the aircraft unhurt. Afterward, the aircraft was towed from the active runway to a parking area 200 m away.

**Fig. No. 4:** *Aircraft's final resting position on runway 34.*

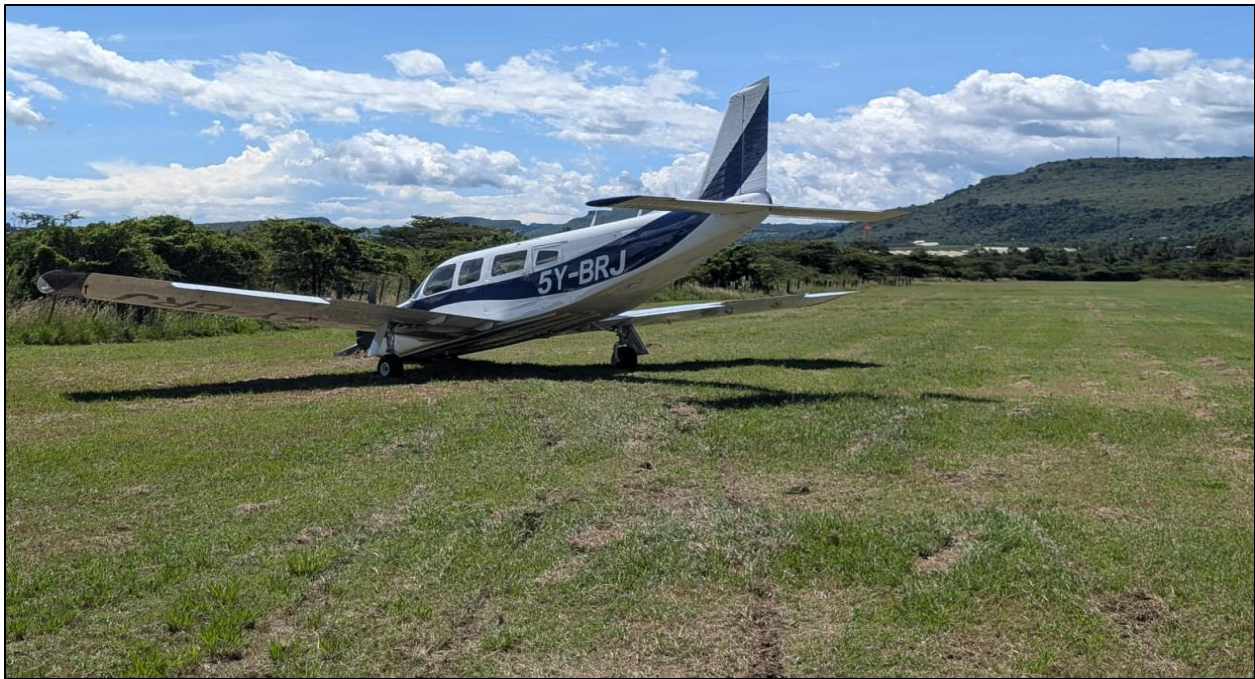
**Fig. No. 5:** *The photograph shows the aircraft's final resting position on Runway 34 and its associated skid marks*

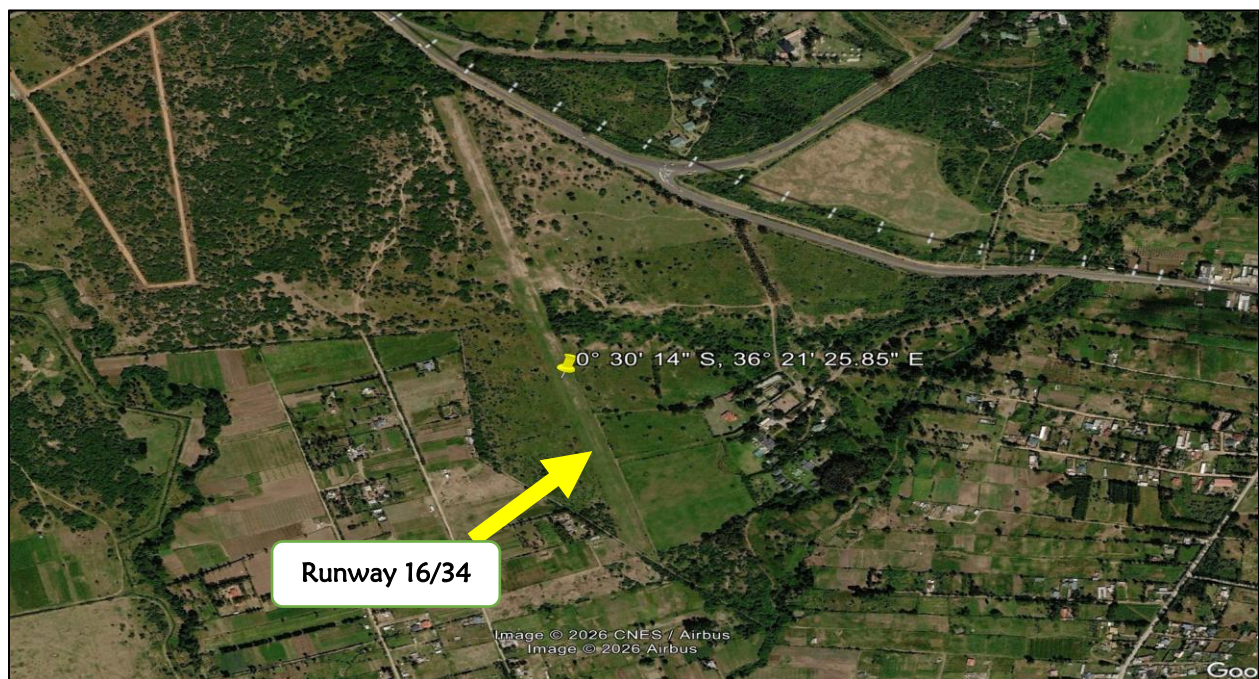
Coulson Airstrip is located in Gilgil, Nakuru County, Kenya. It is a private airstrip with geographic coordinates  $0^{\circ} 30' 14''$  S,  $36^{\circ} 21' 25.85''$  E, located at 2,001 m (6,565 ft) above mean sea level. The airstrip has a single grass runway, designated Runway 16/34, measuring approximately 1,000 m (3,280 ft) by 25 m (82 ft) with a downhill slope towards the threshold of runway 16. There are several small humps along the runway's length.

**Fig. No. 9:** An aerial view of RWY 16/34 (Source: Google Earth with AAID annotation).

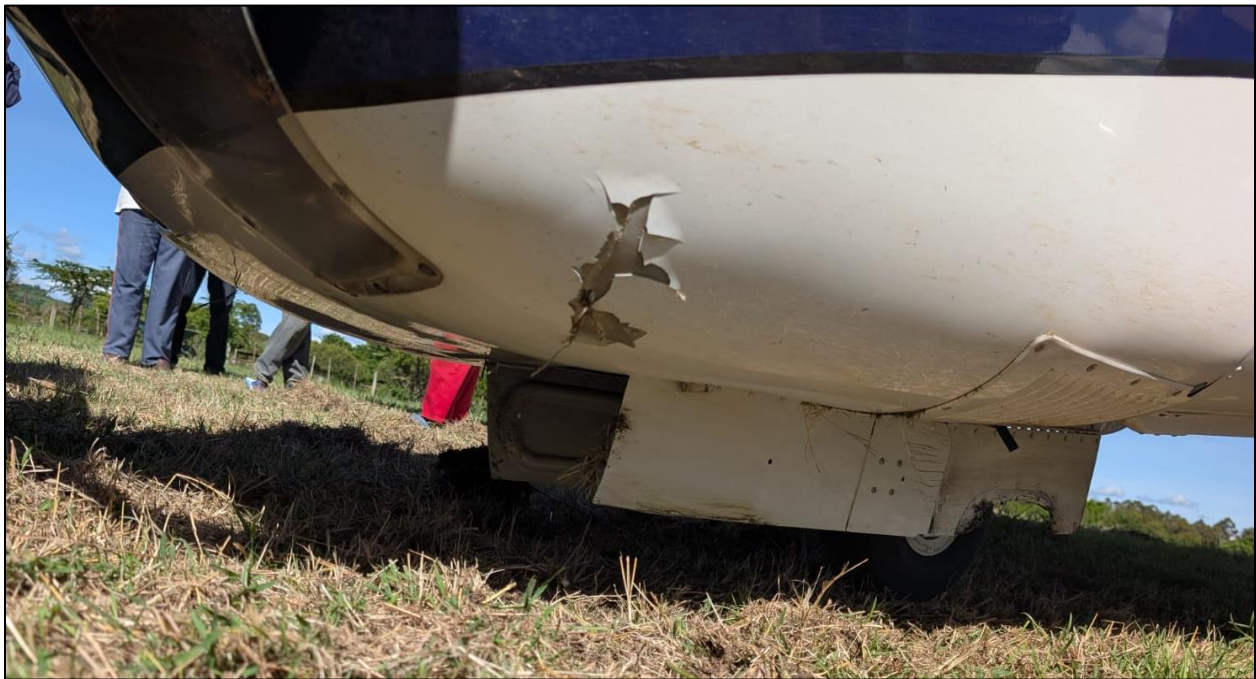
Upon impact, the nose gear down-lock fractured, causing the nose landing gear assembly to collapse. The aircraft slid and came to rest on the left side of the runway, 350 meters from the threshold. The airframe remained structurally intact, with damage limited to propeller blade torsion and lower engine cowling abrasion.

**Fig. No. 10:** *Side view of nose gear damage and lower engine cowling skin delamination.*

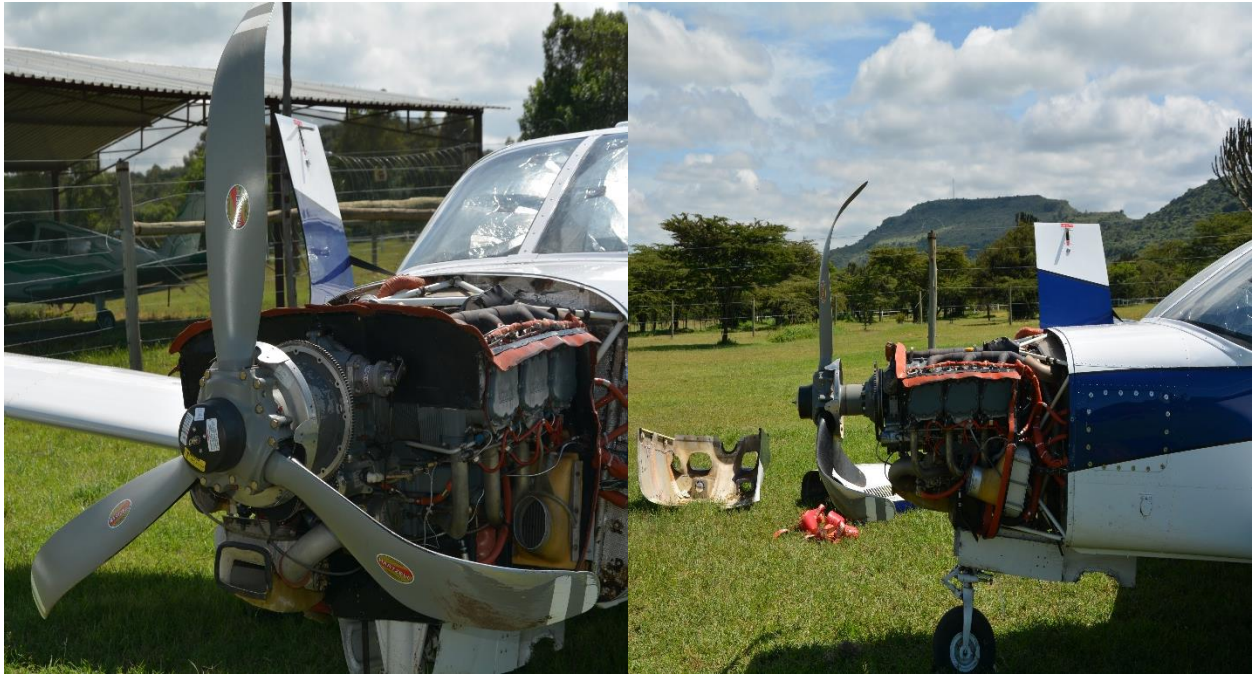
The aircraft sustained damage to all three propeller blades and the nose landing gear assembly.

**Fig. No. 11:** *The damaged propeller.*

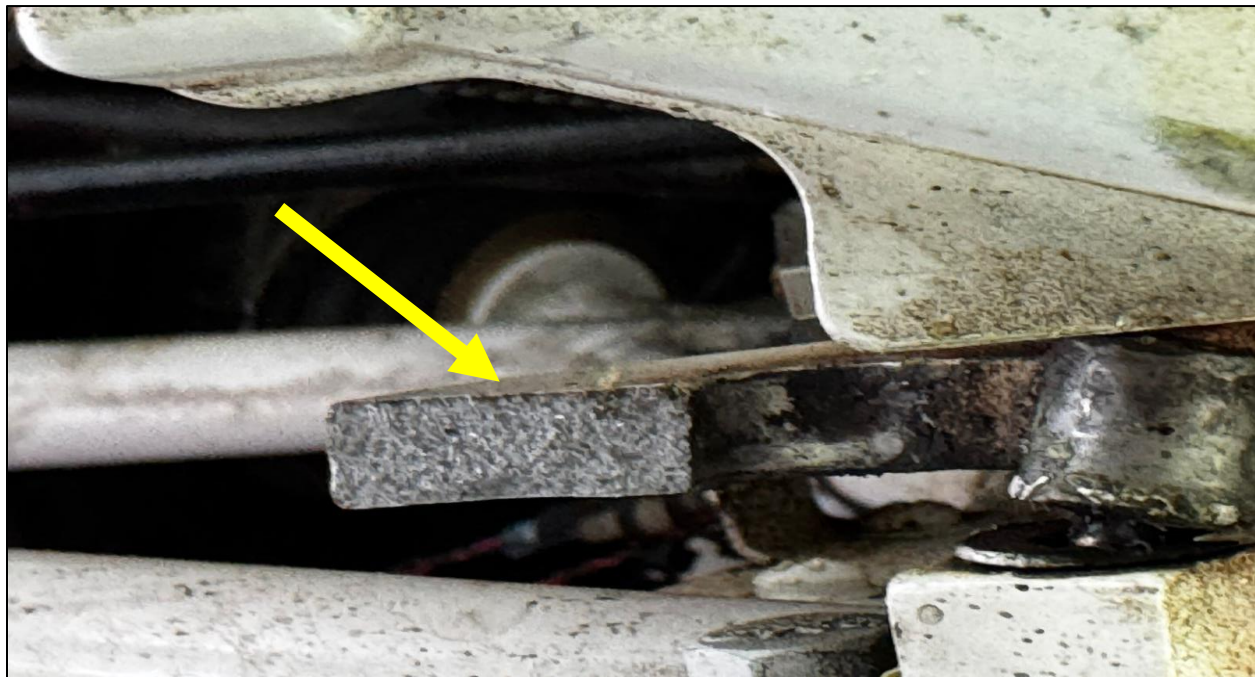
**Fig. No. 12:** *A view of the nose gear down-lock fracture*

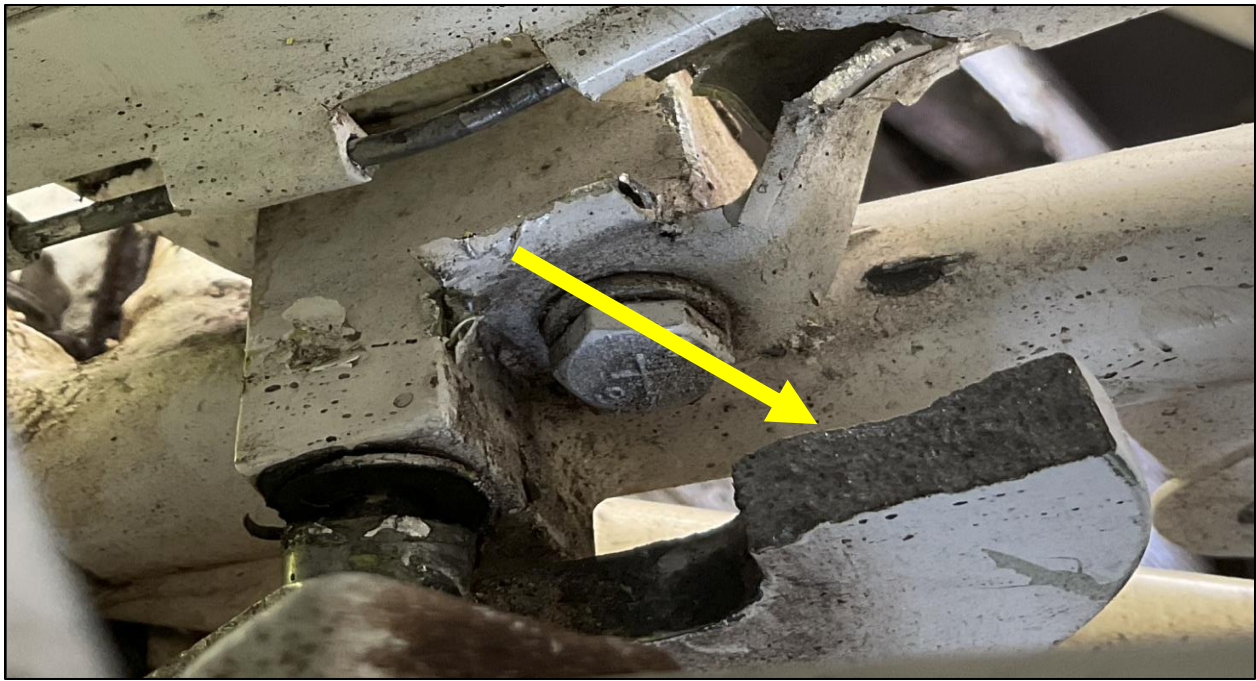
**Fig. No. 13:** *Close-up view of the nose gear down-lock fracture.*

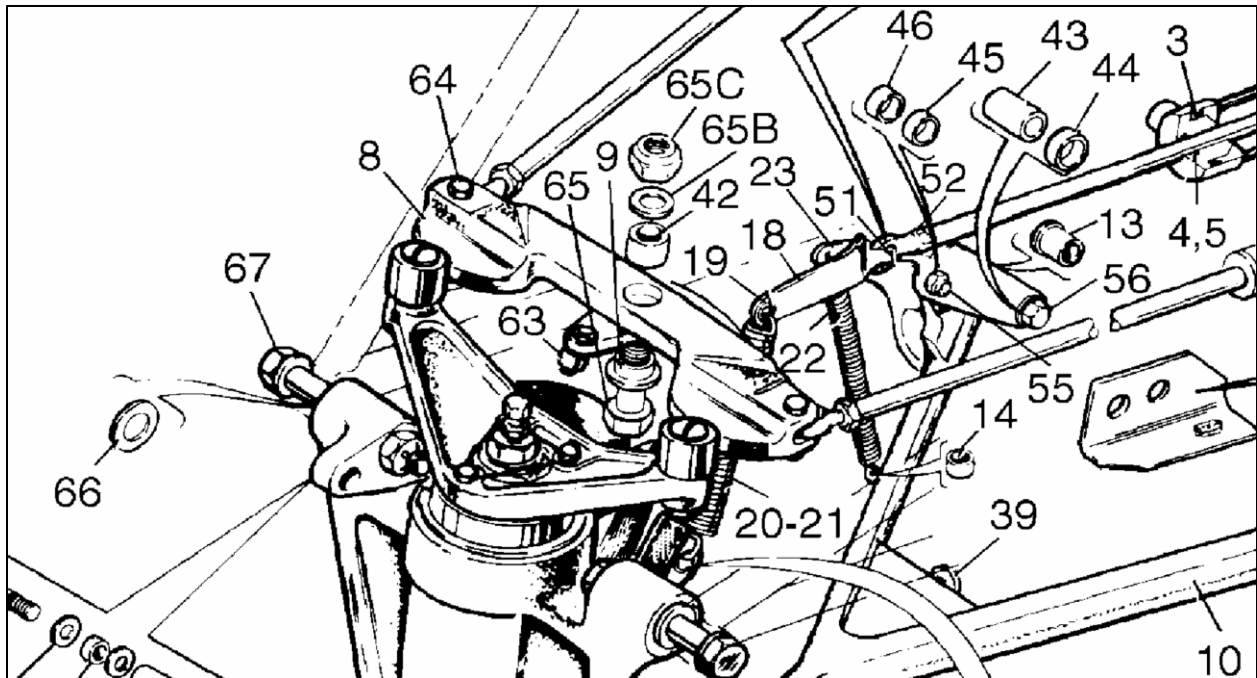
Fig. No. 15: *Nose gear down-lock, close-up view*
