**INVESTIGATION REPORT No. 02/06/2026**

**PRELIMINARY INVESTIGATION REPORT OF A RUNWAY EXCURSION  
INVOLVING A CESSNA 172 REGISTRATION 5Y-BXQ ON 09 JUNE 2026  
AT WILSON AIRPORT, NAIROBI COUNTY, KENYA.**

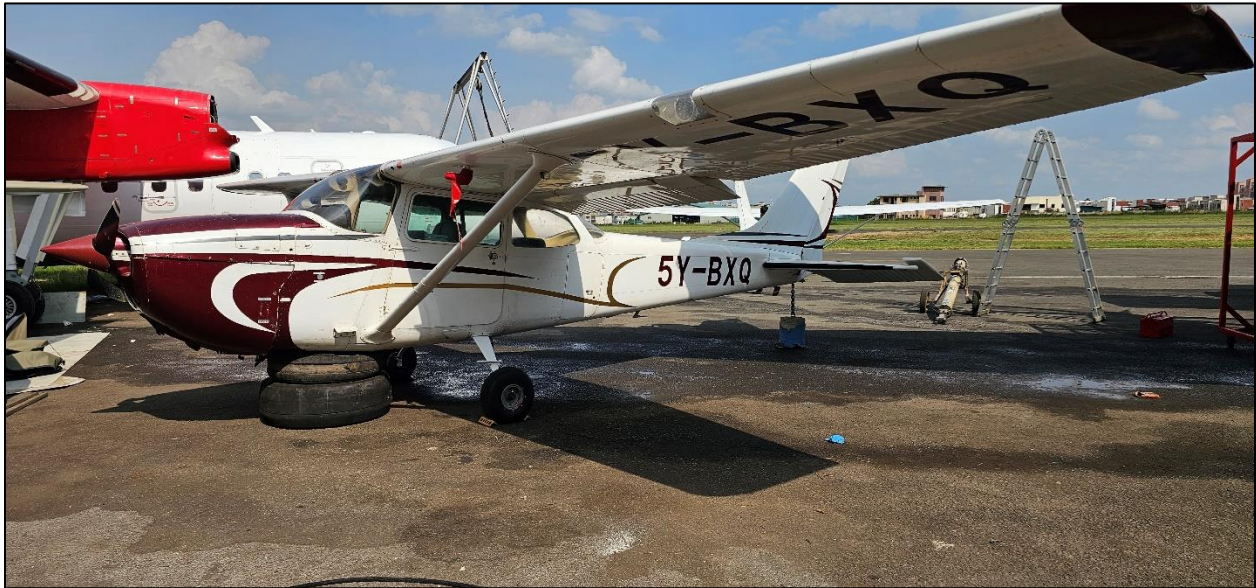
Following the brake failure, the aircraft veered off the runway and entered a ditch, causing the nose landing gear to collapse. The nose landing gear assembly sustained damage, including the breakage of the clamps and steering tubes. The propeller was also damaged after contacting the ground while rotating, following the collapse of the nose landing gear.

**Fig. 2:** *Photo showing 5Y-BXQ after the serious incident*

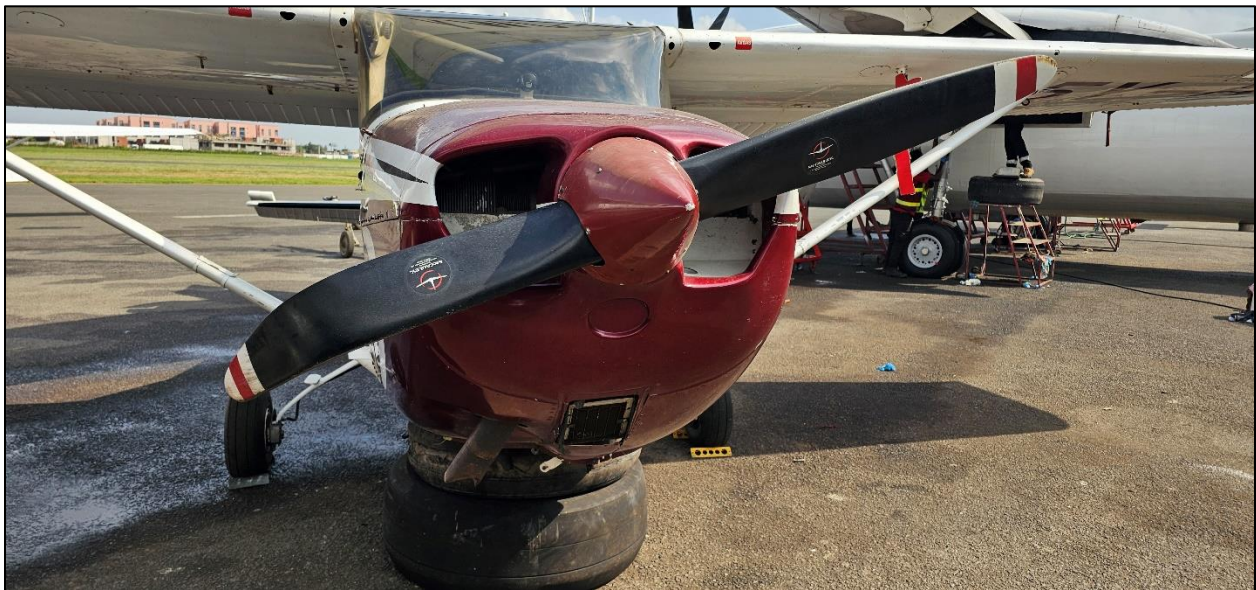
**Fig. 3:** *Photo showing 5Y-BXQ damaged propeller blades*

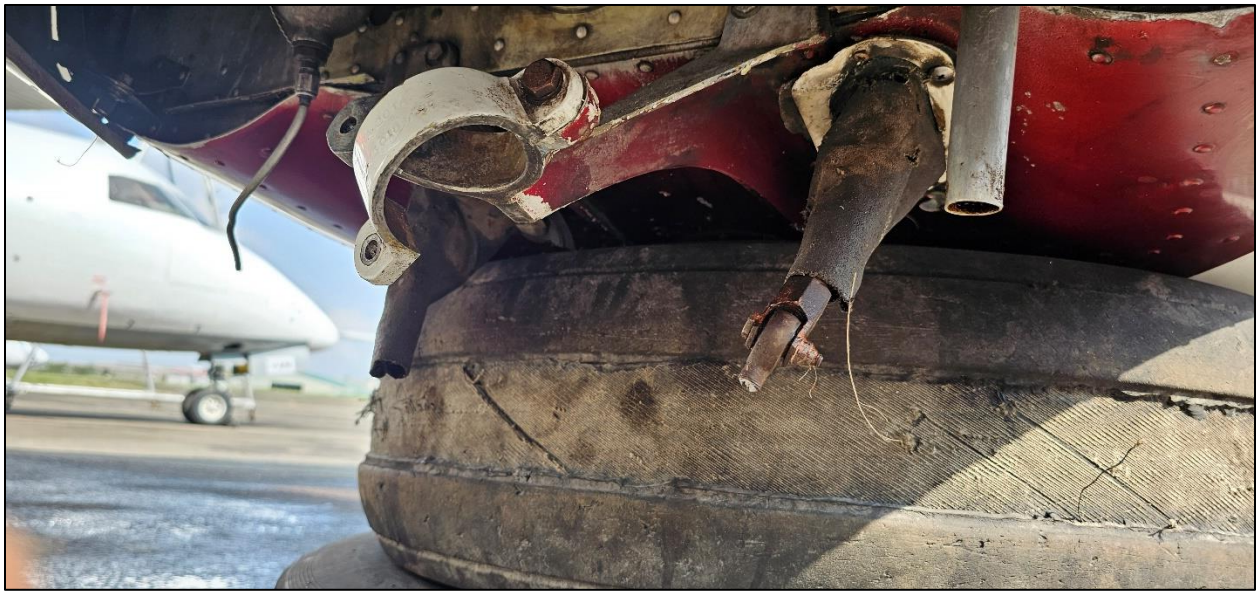
**Fig. 4:** *Photo showing 5Y-BXQ damaged struts and steering tubes*

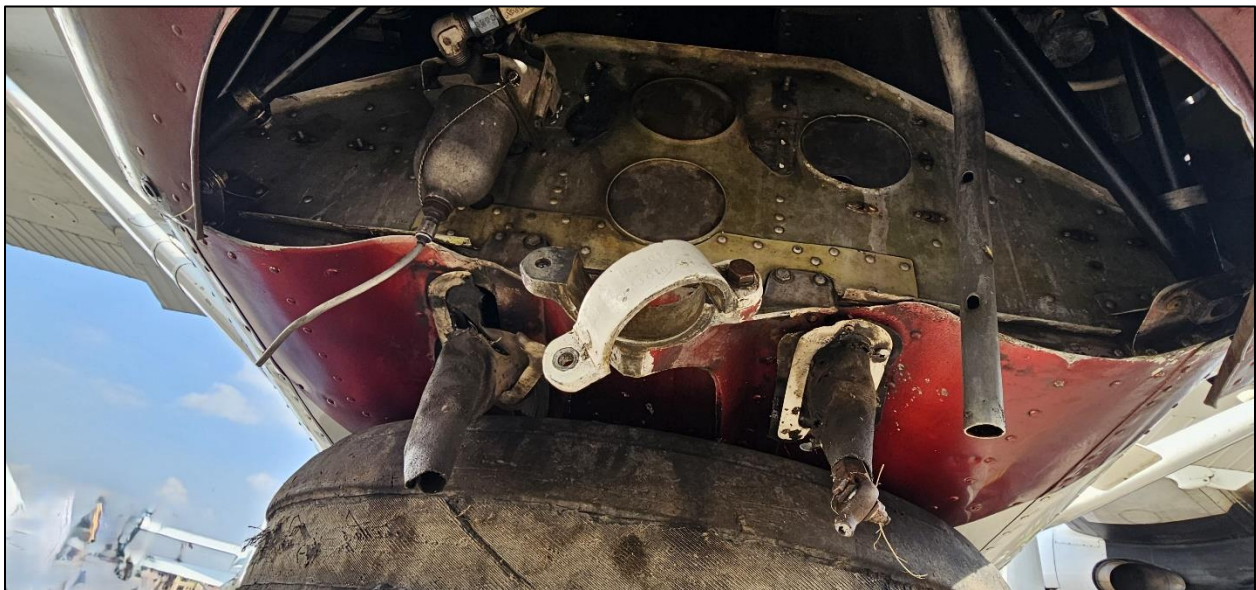
**Fig. 5:** *Photo showing 5Y-BXQ damaged nose gear assembly*

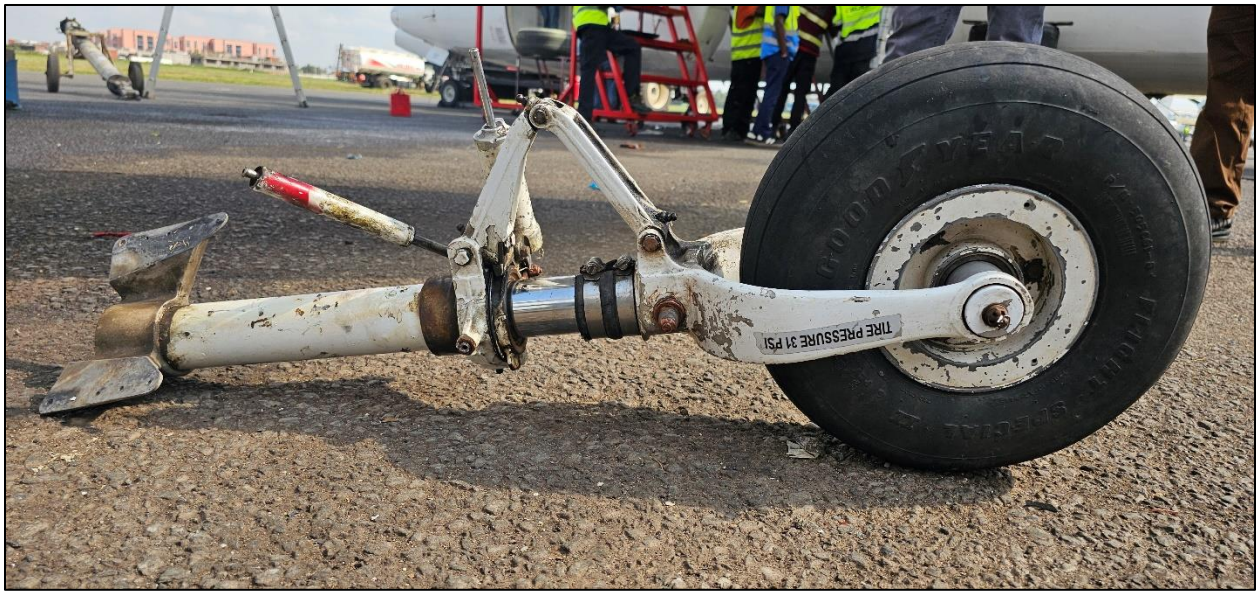
The impact with the ditch caused the nose landing gear to collapse, bringing the aircraft to a stop. The occurrence resulted in substantial damage to the nose landing gear and any associated airframe components affected by the runway excursion.

**Fig. 6:** *Photo showing 5Y-BXQ damaged nose gear*
