**INVESTIGATION REPORT No. 02/04/2026**

**PRELIMINARY INVESTIGATION REPORT ON A RUNWAY OVERRUN  
INCIDENT INVOLVING AN EMBRAER 120 AIRCRAFT, REGISTRATION 5Y-EBB,  
ON 24 APRIL 2026 AT MANDERA AIRPORT, MANDERA COUNTY, KENYA.**

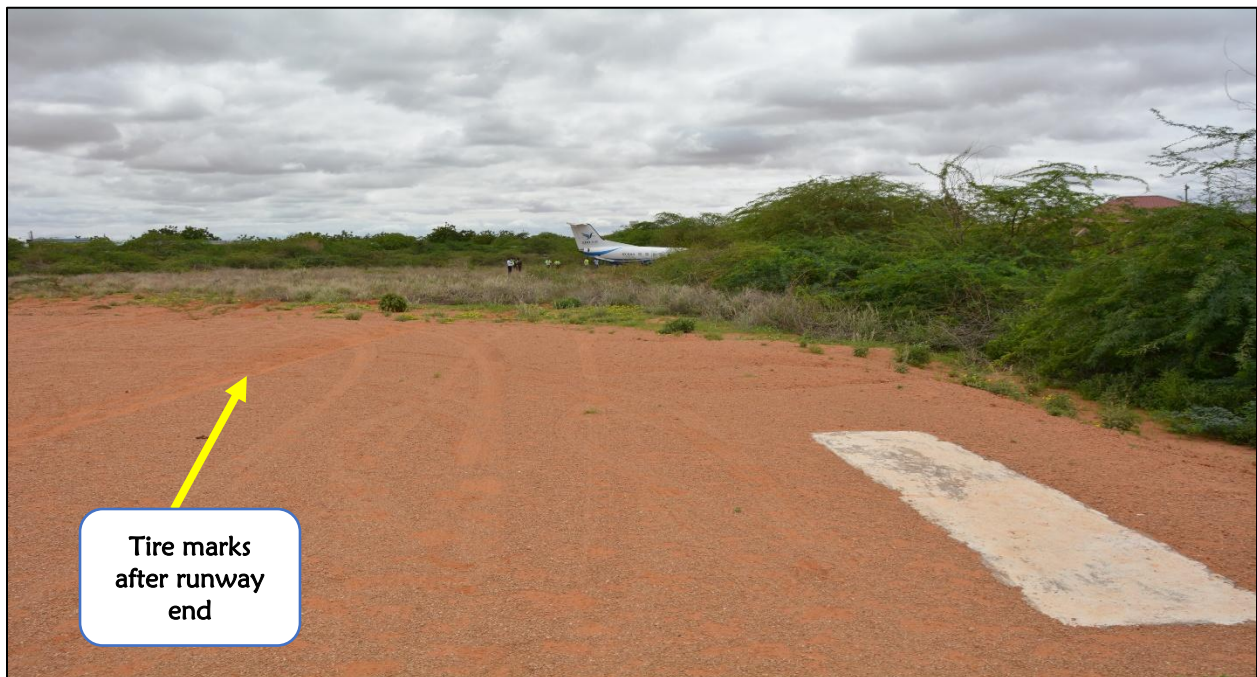
According to the flight crew, the approach to HKMA Runway (RWY) 05 was stable, and all flight parameters were normal. Upon touchdown at 0545 (0845), the crew reported that despite applying normal braking pressure, the aircraft did not decelerate as expected and could not stop within the remaining runway distance. The flight crew then applied maximum reverse thrust and emergency braking in an unsuccessful attempt to stop the aircraft, leading to a runway overrun. The crew issued the command "brace," just before impact. The aircraft impacted the aerodrome's perimeter fence, a thicket, and a small embankment, coming to rest facing 90° right of the runway, 89 metres from the end of the runway.

**Fig. No. 2:** A photo illustrating the runway threshold, tire marks, and the aircraft's final resting position.

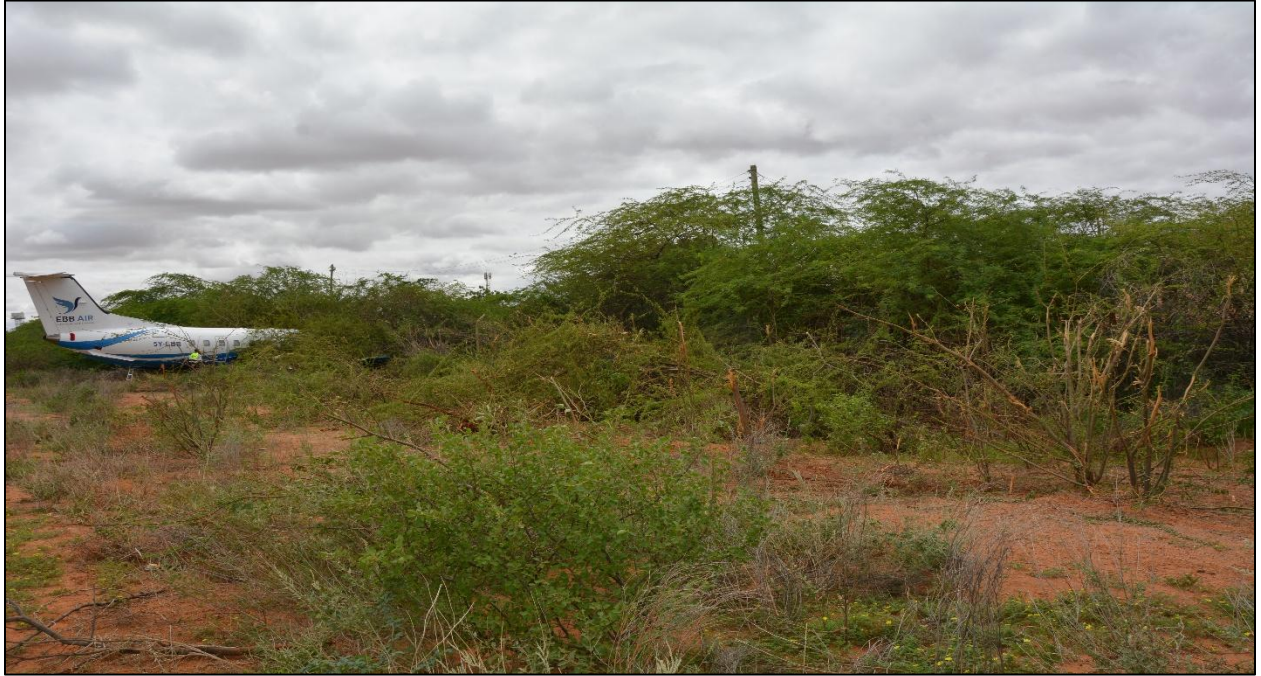
**Fig. No. 3:** A photo showing the damage to the thicket along the aircraft's direction of motion

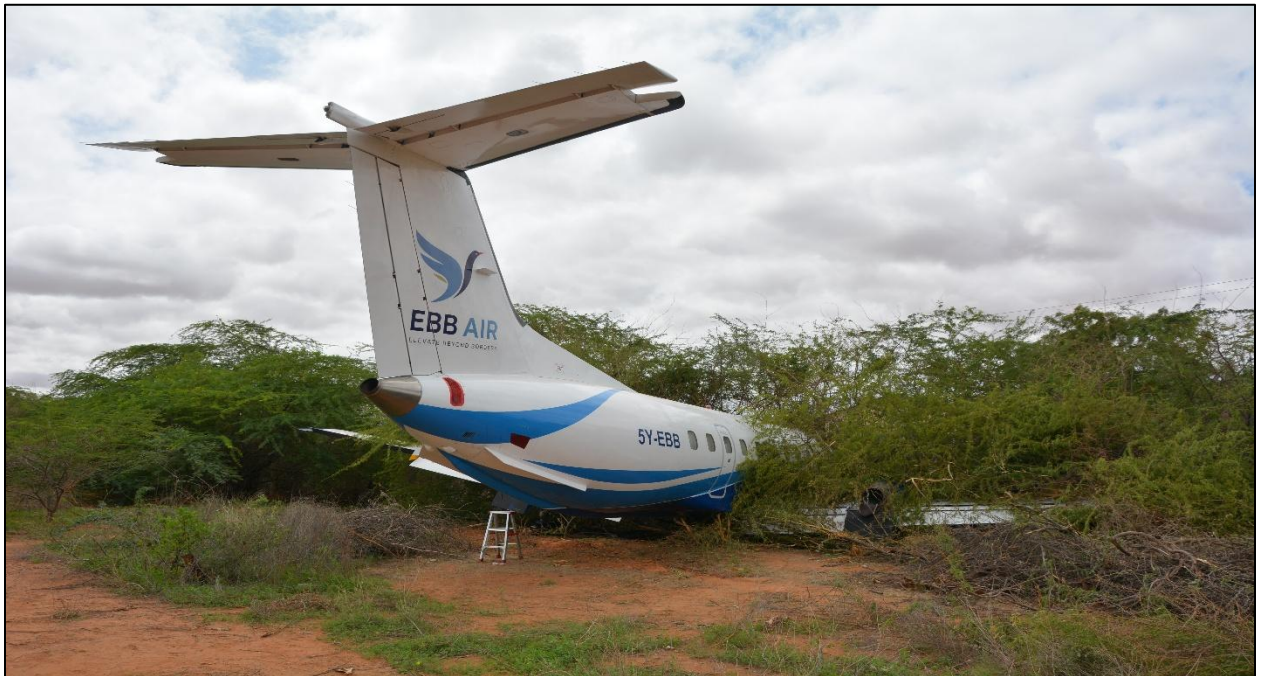
**Fig. No. 4:** A photo of the aircraft's empennage

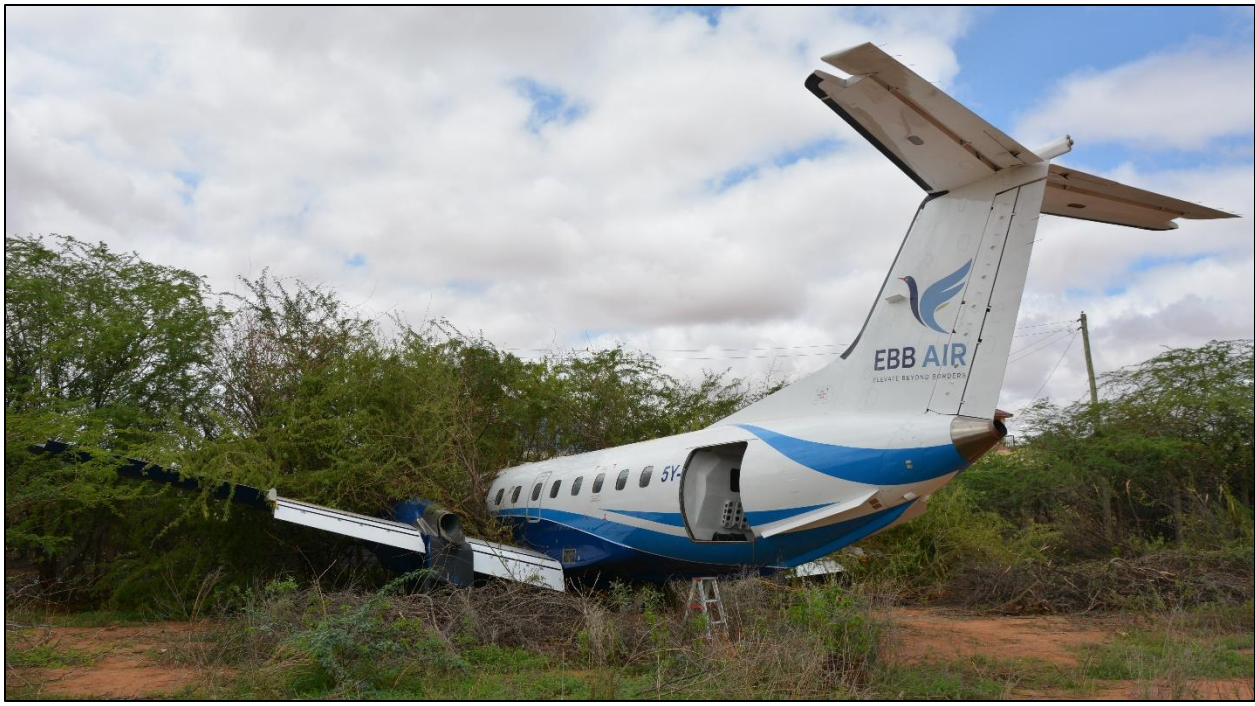
**Fig. No. 5:** *A different view of the aircraft's resting position*

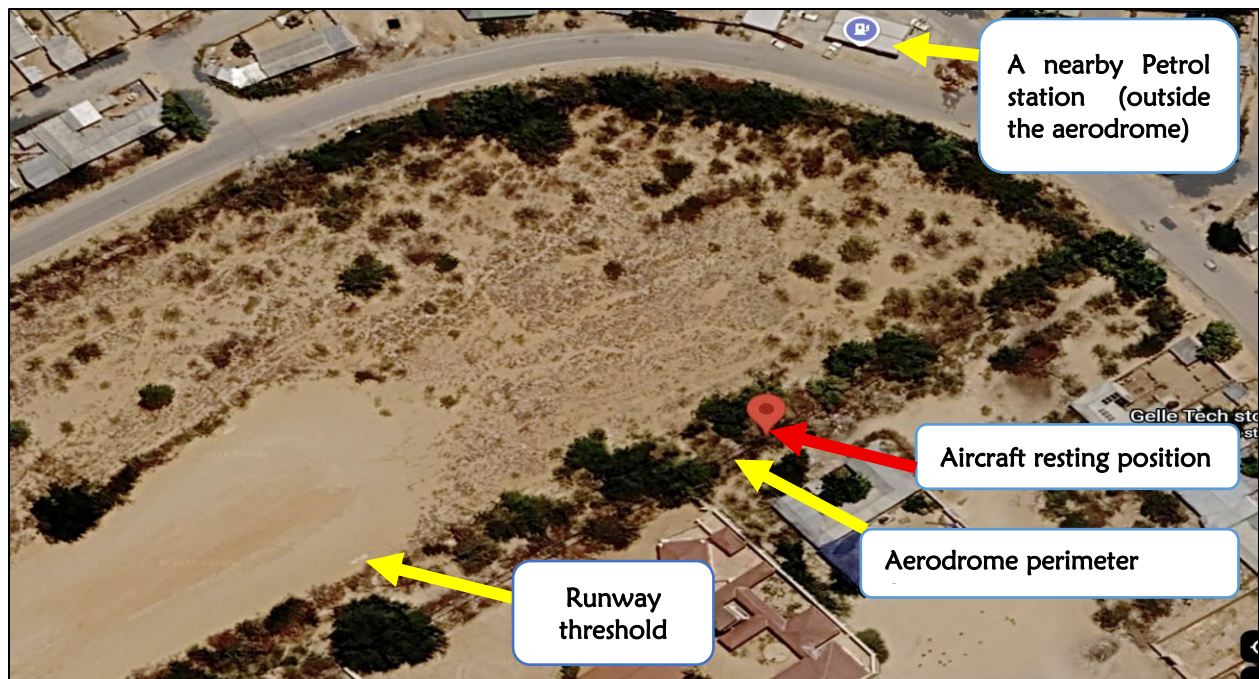
**Fig. No. 13:** Aerial view illustrating the aircraft's final resting position relative to the runway threshold, the aerodrome perimeter fence, and the nearby petrol station (Source: Google Maps).

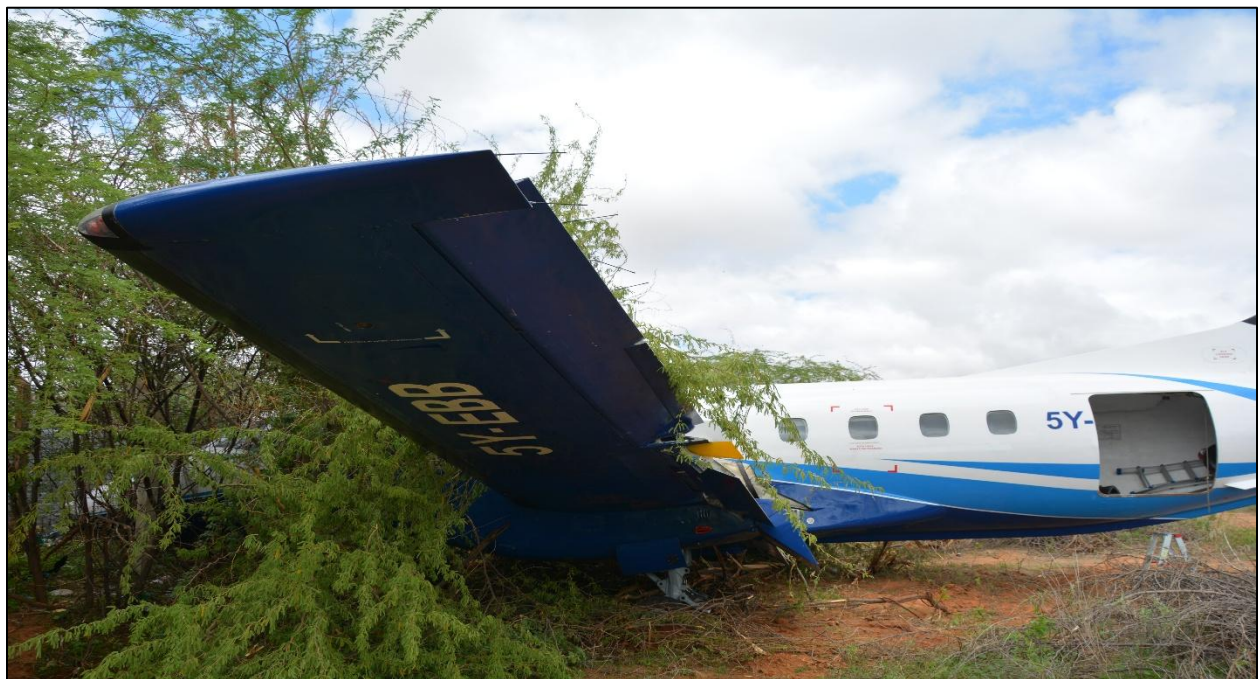
**Fig. No. 14:** A left-side photo of the aircraft

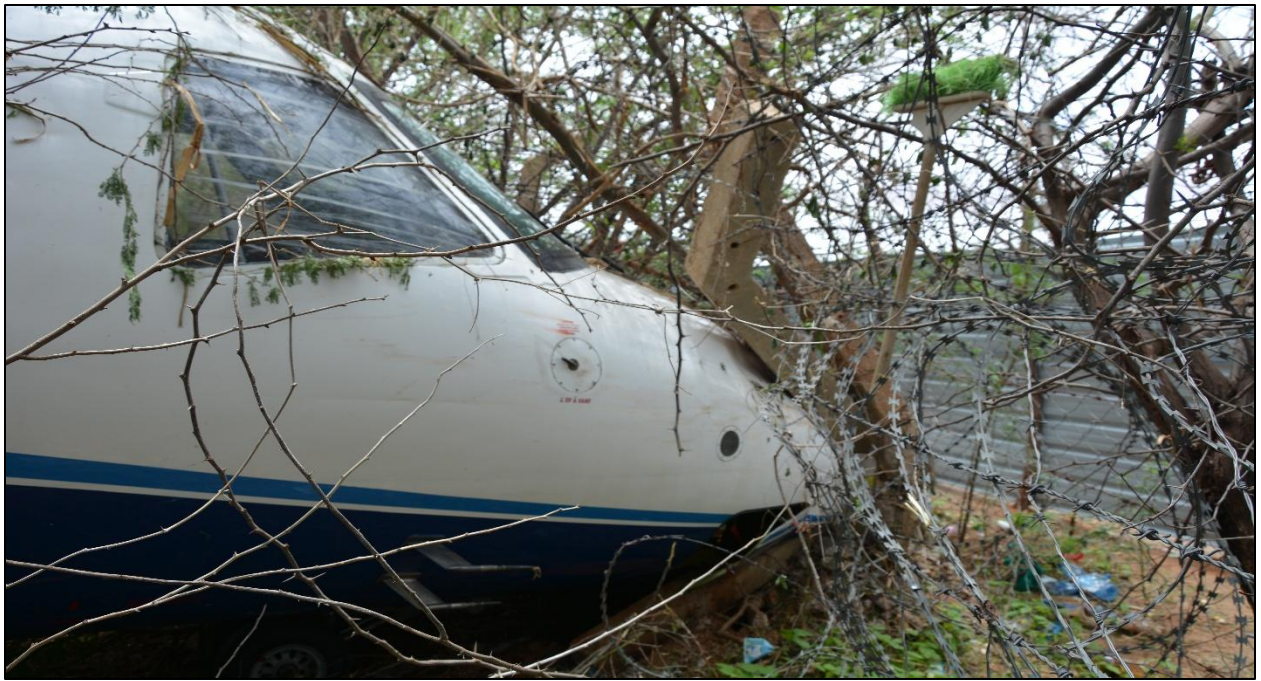
The aircraft impacted and damaged the aerodrome's perimeter chain-link fence and concrete poles.

The main landing gear embedded in the soft ground; the left inboard tire deflated. The nose landing gear collapsed aft and detached from its attachment fittings. The nose section impacted the aerodrome perimeter fence, damaging both the fencing and its support poles.

**Fig. No. 15:** *Aircraft entangled in the perimeter fence and associated poles.*

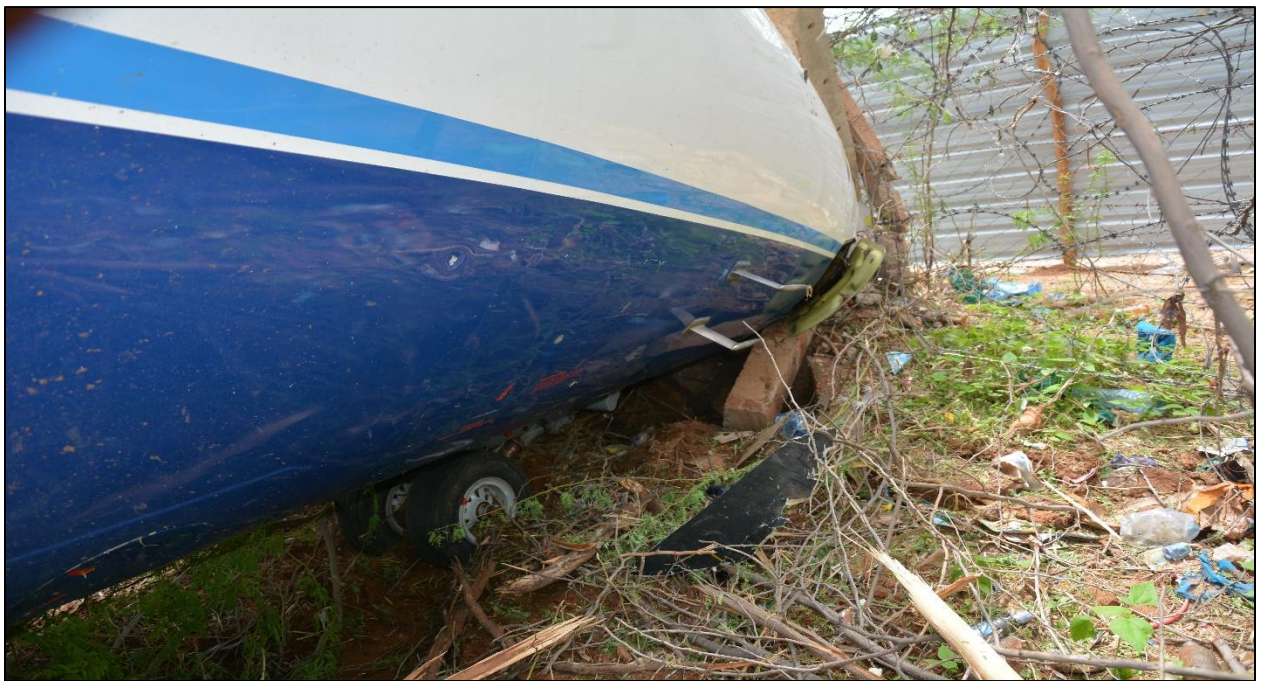
**Fig. No. 16:** *Right-side view of the aircraft*

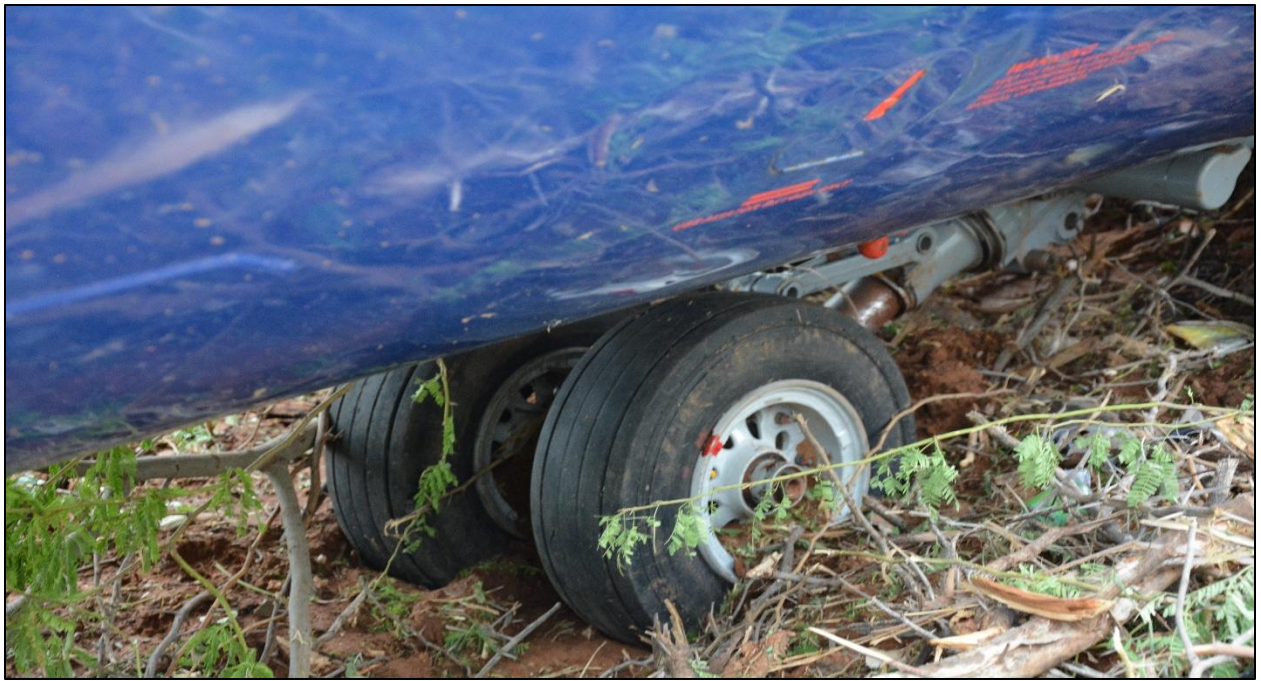
**Fig. No. 17:** *The nose landing gear*

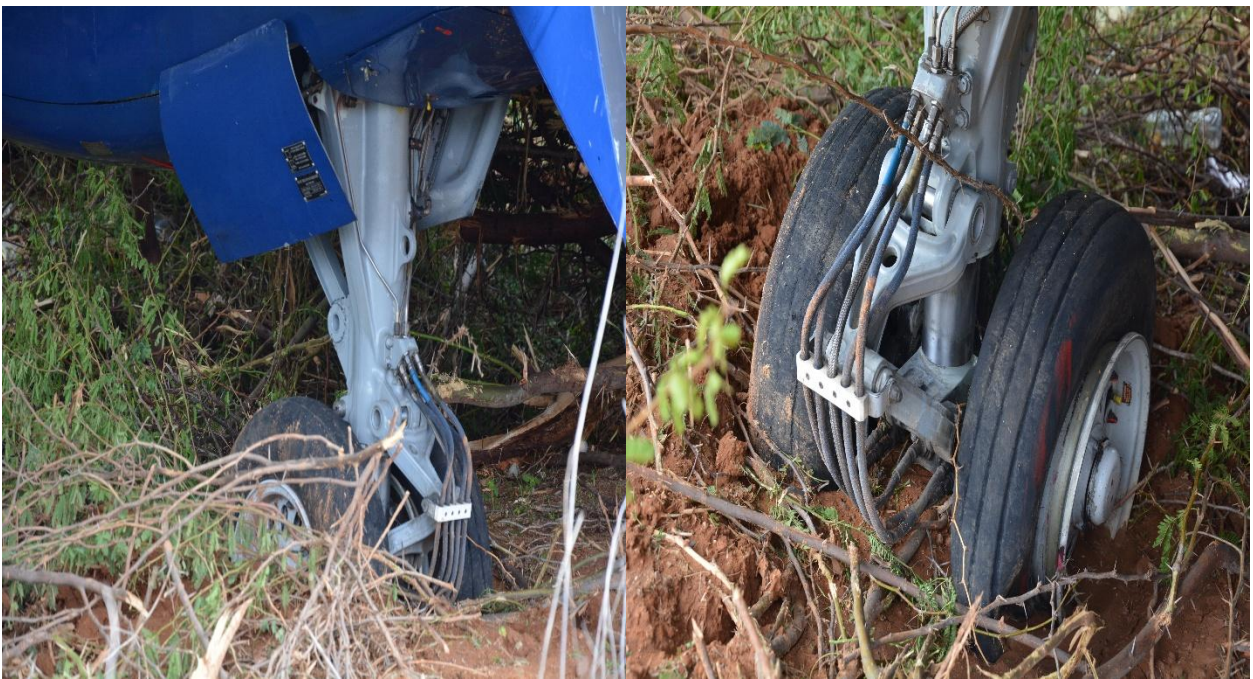
**Fig. No. 18:** *Right main landing gear embedded in the soft ground, and left inboard deflated tire.*

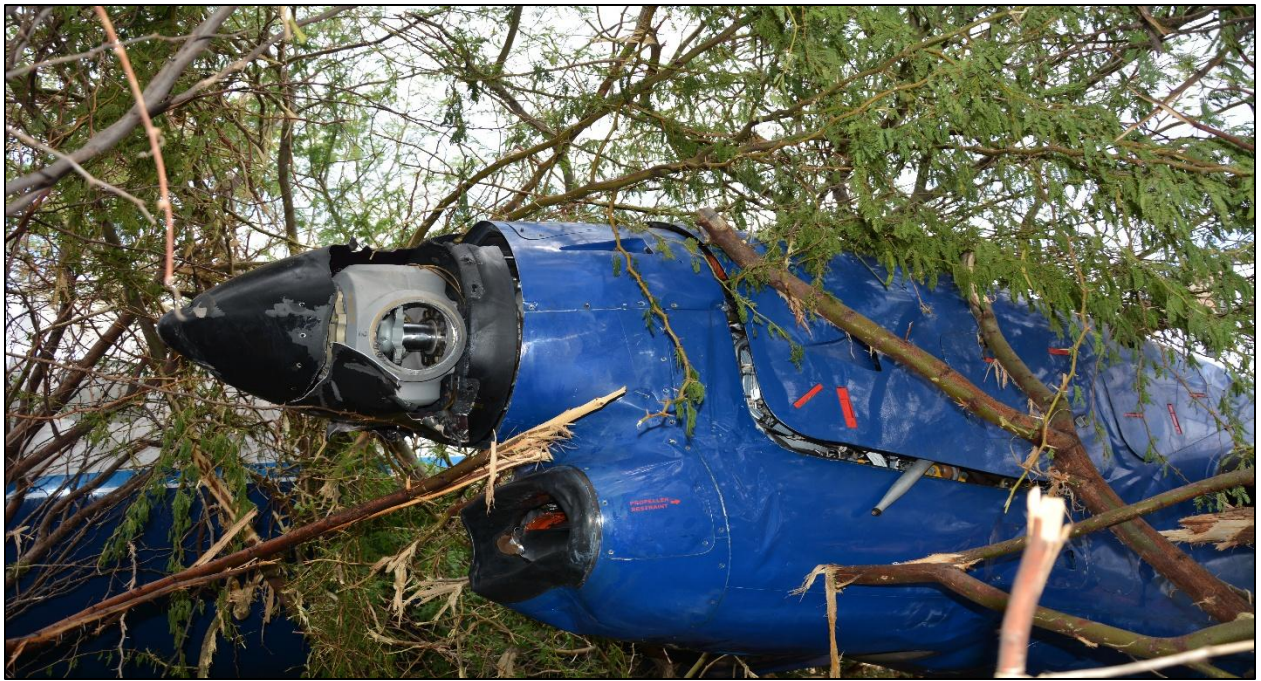
The propeller blades of Engine No. 1 detached from their hub and exhibited torsional damage. The upper engine cowling exhibited fire damage. The Engine No. 2 propeller blades suffered a mid-span separation and exhibited torsional damage.

**Fig. No. 19:** *Engine No. 1 propeller hub assembly missing all blades.*

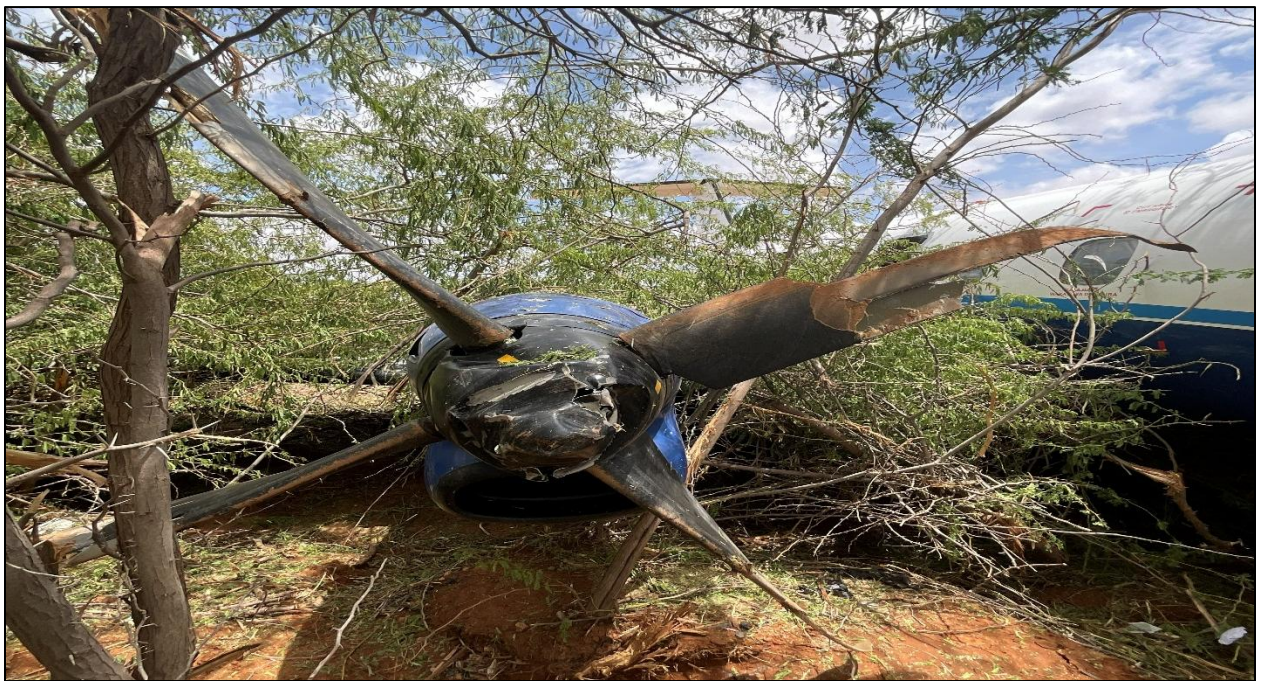
**Fig. No. 20:** *View of Engine No. 2 propeller blades exhibiting mid-span separation and spinner damage*

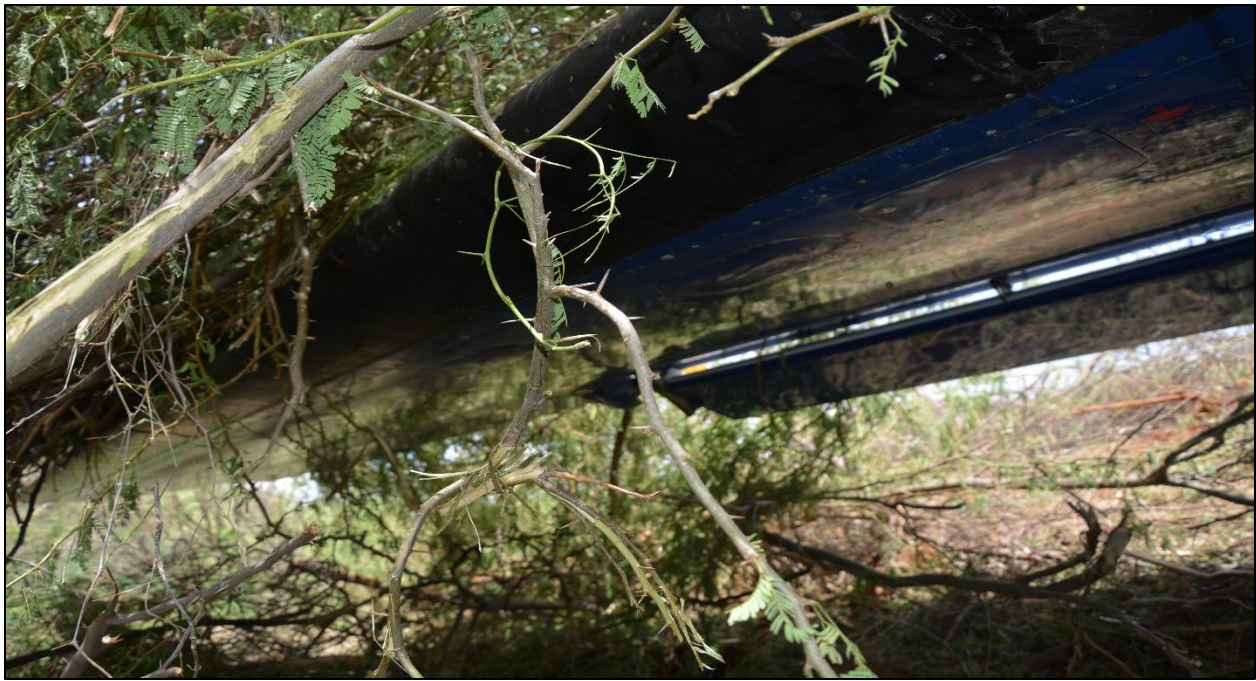
**Fig. No. 21:** *View of the right-wing leading edge with thicket on the top surface*

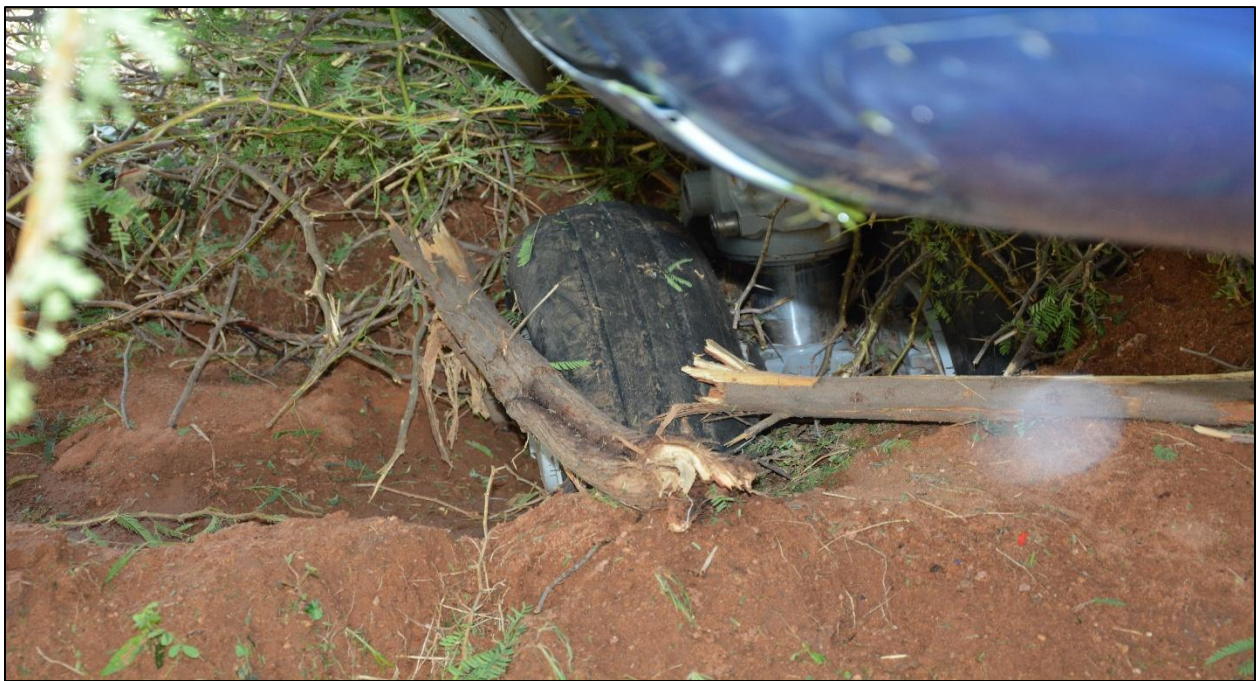
**Fig. No. 22:** *Right main landing gear embedded in the soft ground*

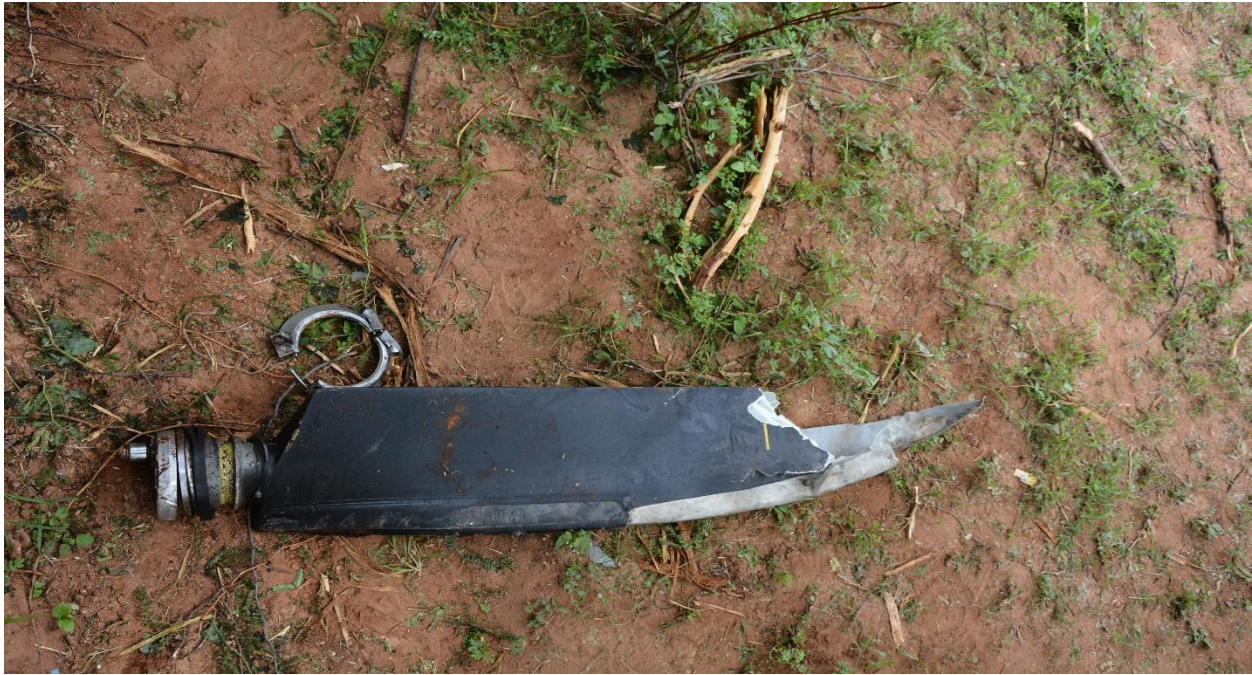
**Fig. No. 23:** *A propeller blade exhibiting torsional damage.*

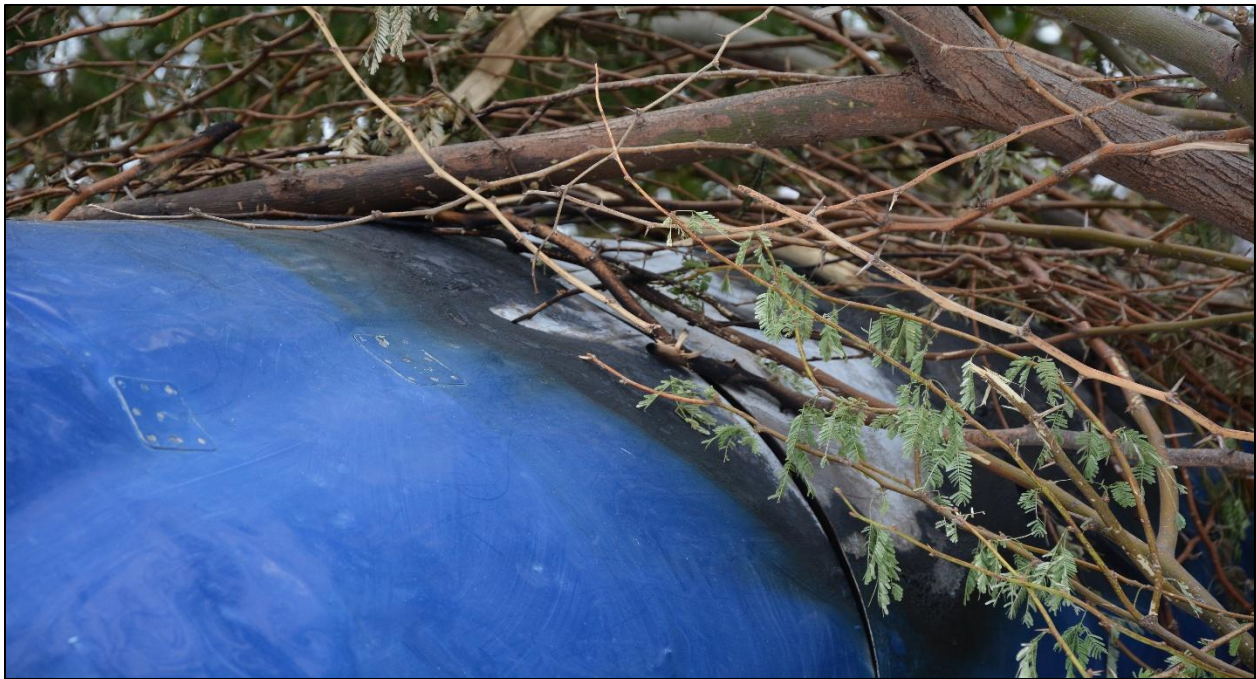
A post-impact fire in Engine No. 1 was initially suppressed by the flight crew and subsequently extinguished by the local County fire engine.

**Fig. No. 24:** *Engine No.1 engine upper cowling exhibiting thermal distress.*

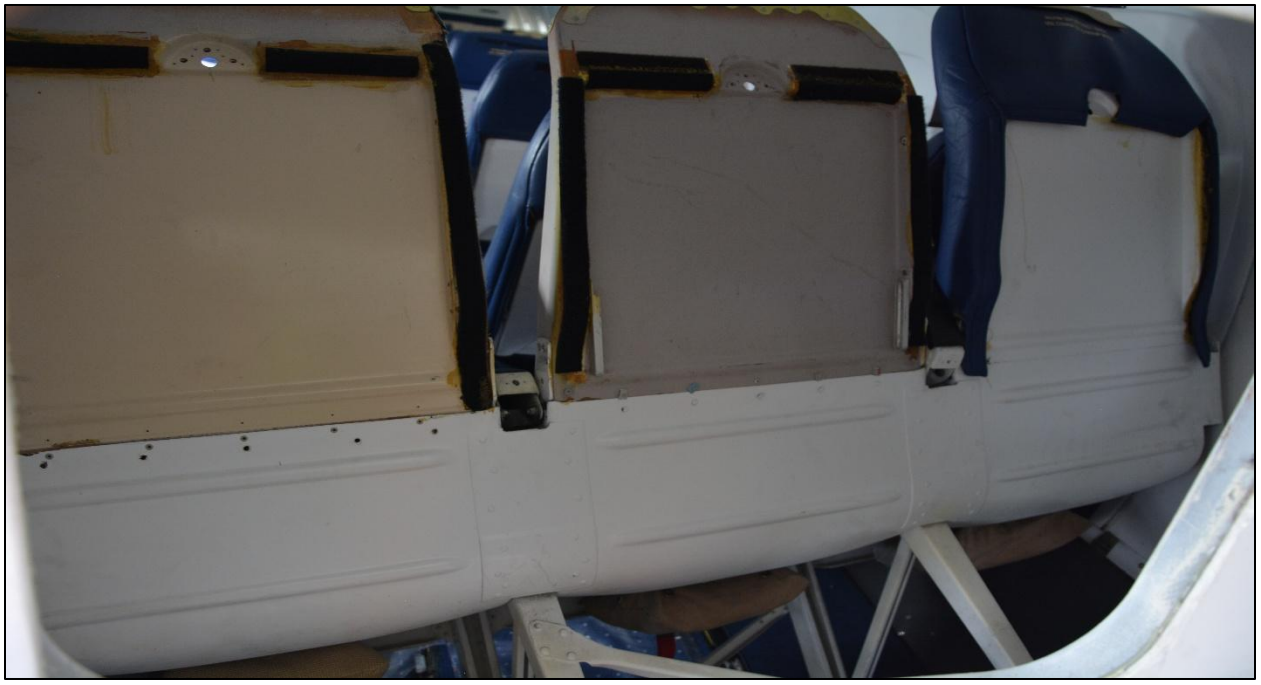
An inspection of the cabin and cockpit revealed that all seatbelts and shoulder harnesses remained intact. However, the aft-row passenger seats and the baggage compartment bulkhead partition were displaced.

**Fig. No. 25:** *Post-crash aft-row passenger seats and baggage compartment bulkhead/partition exhibiting displacement*

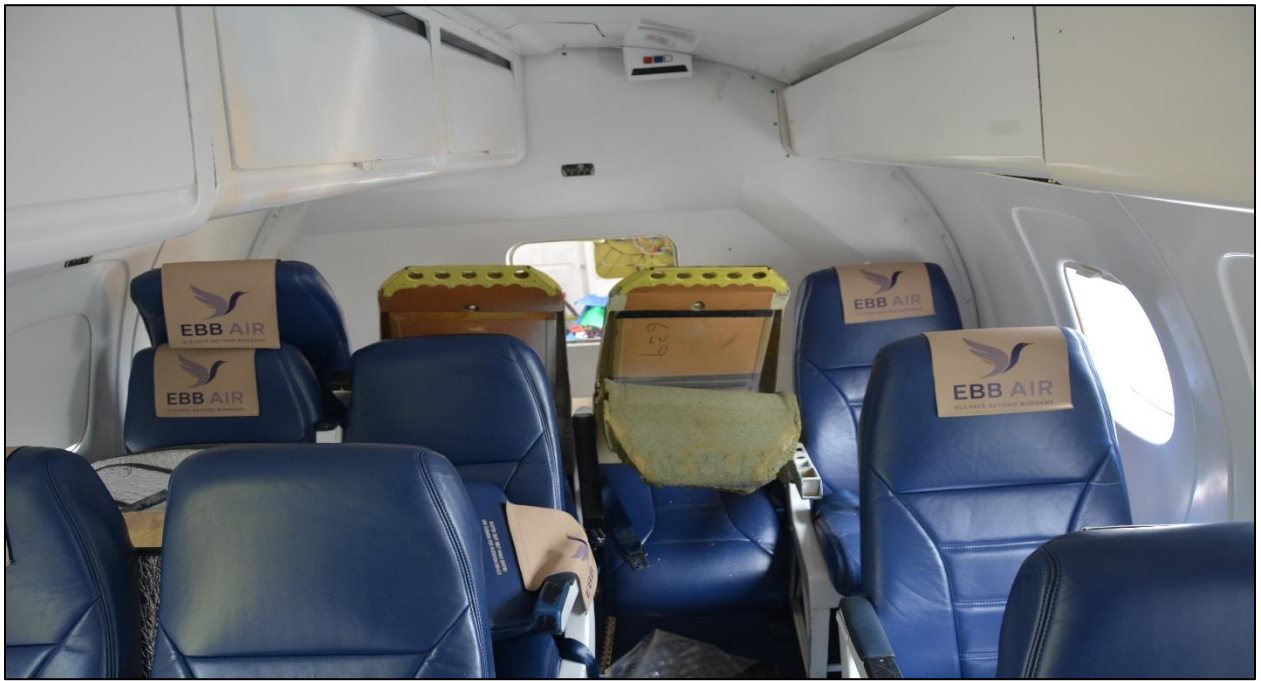
**Fig. No. 26:** *Post-crash aft-row passenger seats and baggage compartment bulkhead/partition exhibiting displacement.*

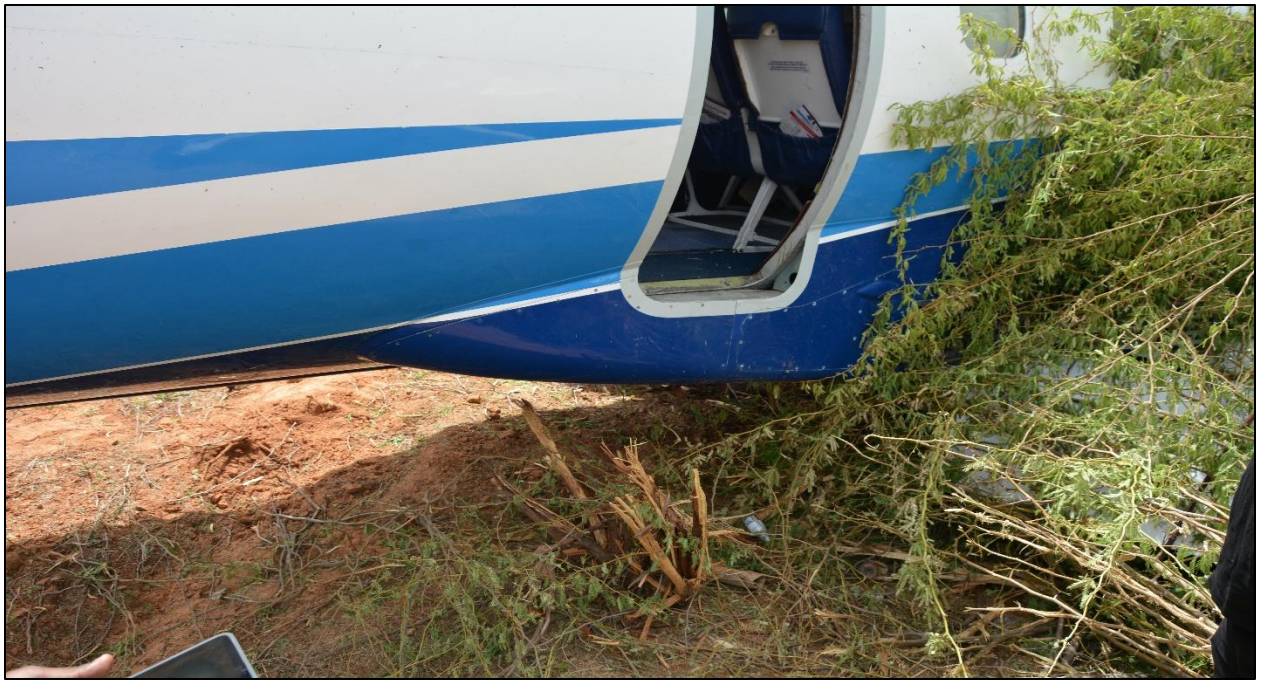
**Fig. No. 27:** *View of left emergency exit door.*

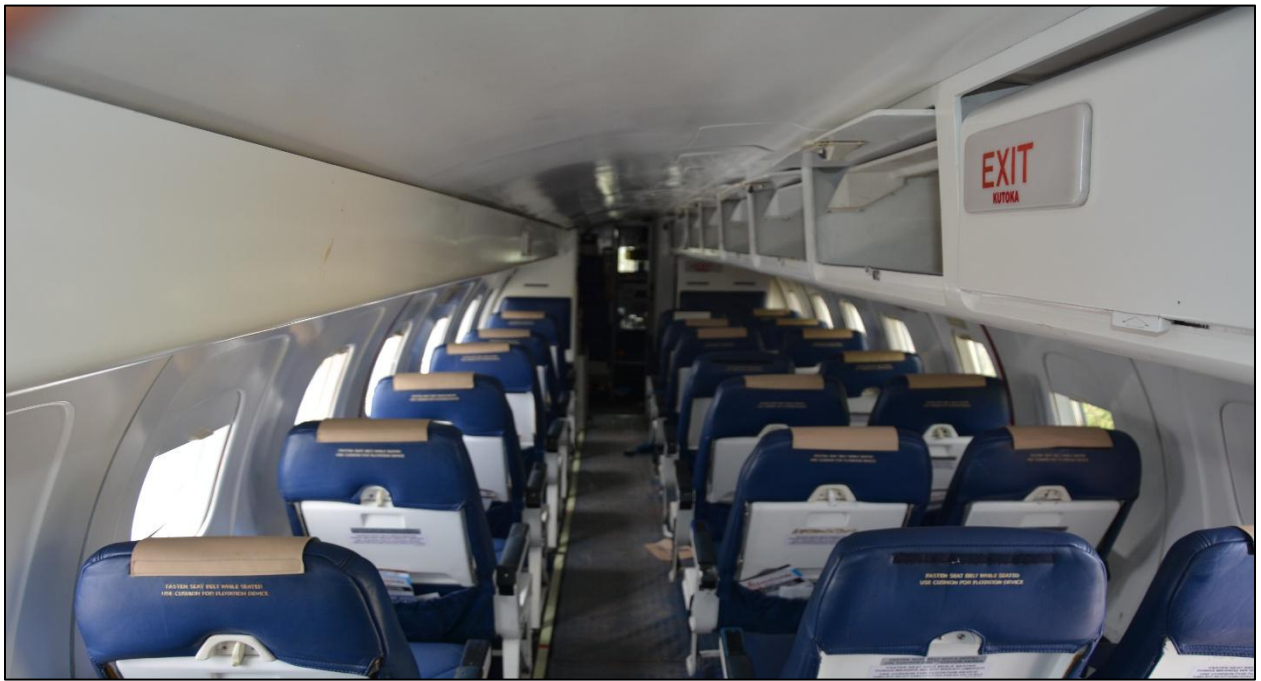
**Fig. No. 28:** *Post-crash cabin interior exhibiting no seat displacement*

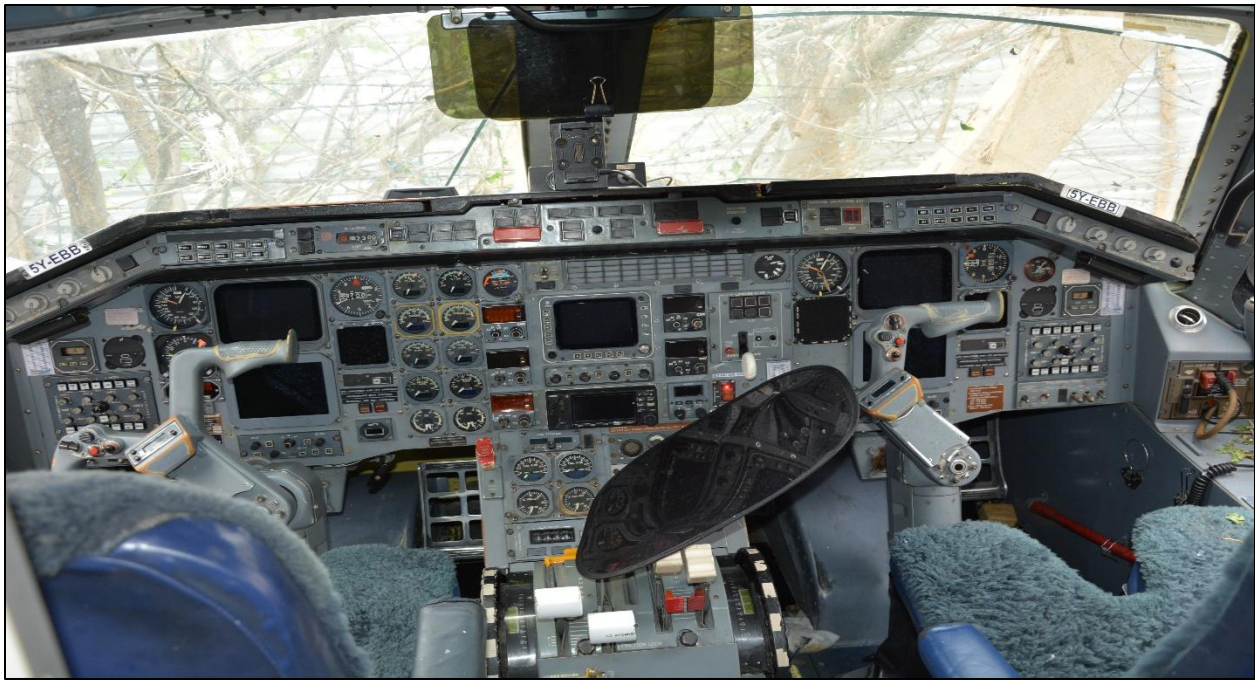
**Fig. No. 29:** *Post-crash view of the cockpit*
