MINISTRY OF ROADS AND TRANSPORT  
STATE DEPARTMENT FOR AVIATION  
AND AEROSPACE DEVELOPMENT  
AIRCRAFT ACCIDENT INVESTIGATION DEPARTMENT

**REPORT No. 01/02/2023**

FINAL INVESTIGATION REPORT ON THE GROUND  
COLLISION INCIDENT INVOLVING TWO KENYA AIRWAYS  
EMBRAER 190 AIRCRAFT, REGISTRATION 5Y-KYT AND  
5Y-KYQ, ON 26 FEBRUARY 2023 AT THE JOMO KENYATTA  
INTERNATIONAL AIRPORT, NAIROBI COUNTY, KENYA.

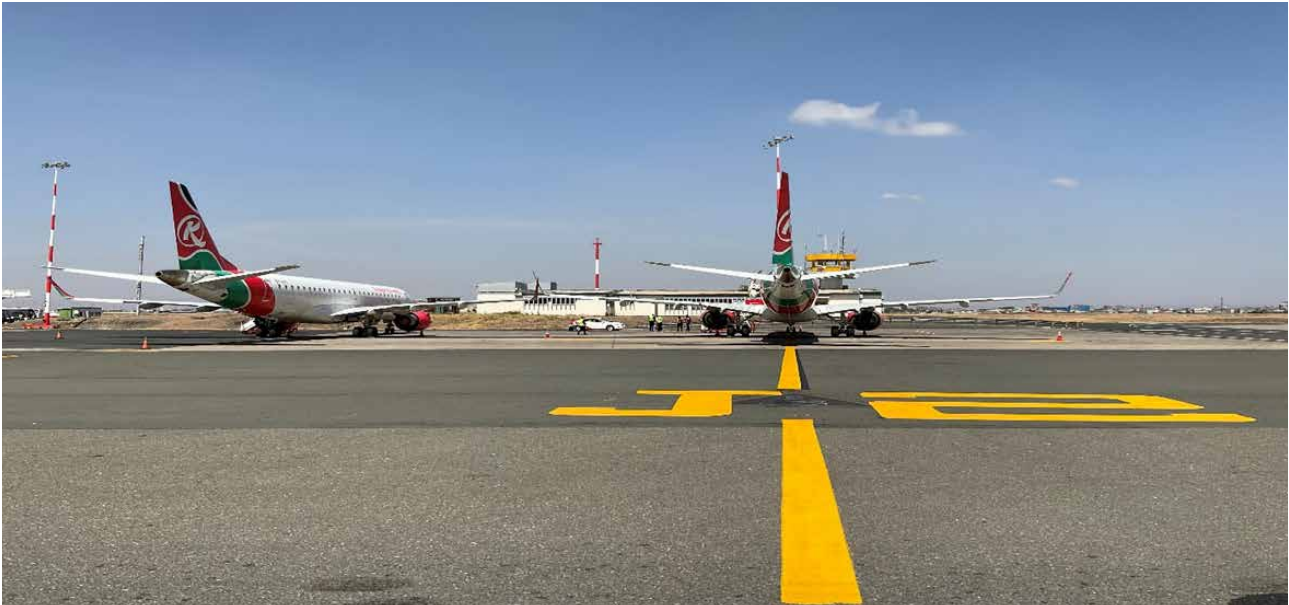
The flight crew of 5Y-KYT reported that the aircraft was marshalled into bay J2A with 5Y-KYQ aircraft parked overnight at **J2**, resulting in a wing tip collision. The flight crew further reported that it was assigned bay **J2** by operations control and, on approaching the bay, the ground marshaller guided the aircraft towards abeam bay **J2** as there was another aircraft parked at the bay and that, with no markings to indicate the correct alignment into J2A, the crew followed the marshaller's instructions. Approaching the last few feet of marshalling, the aircraft's right-wing tip came into contact with that of the adjacent aircraft and the crew

**Figure 1:** A photo depicting the stationary aircraft 5Y-KYQ parked in J2 parking bay and 5Y-KYT parked in the left allocated space abeam 5Y-KYQ.

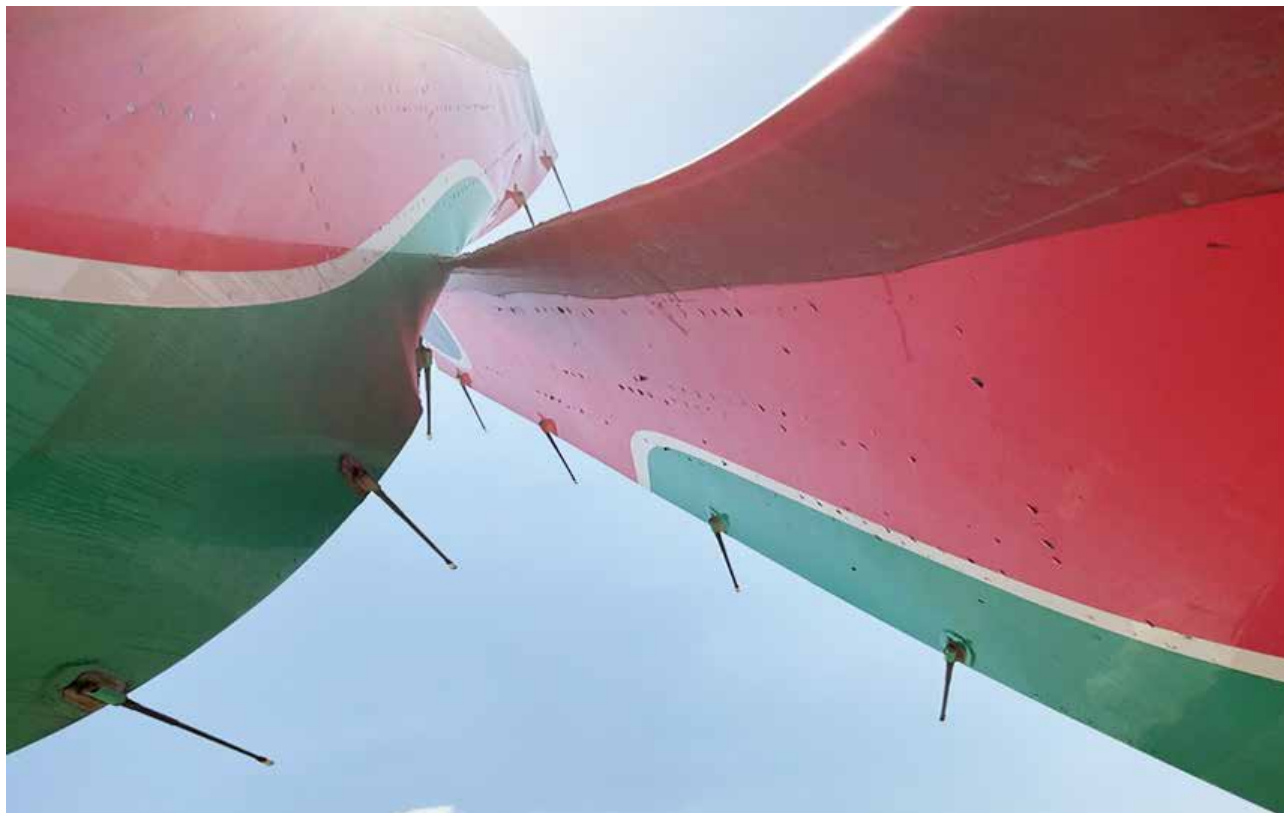
The aircraft's right wing tip's leading edge sustained slight damage when it came into contact with the left-wing tip of 5Y-KYQ.

**Figure 2:** A photo depicting the minor damage to the right-wing tip of 5Y-KYT.

The probable cause of the ground collision incident was the ground crew's failure to allow sufficient clearance between the two aircraft, resulting in wingtip collision and subsequent minor damage to the two aircraft's wingtips.

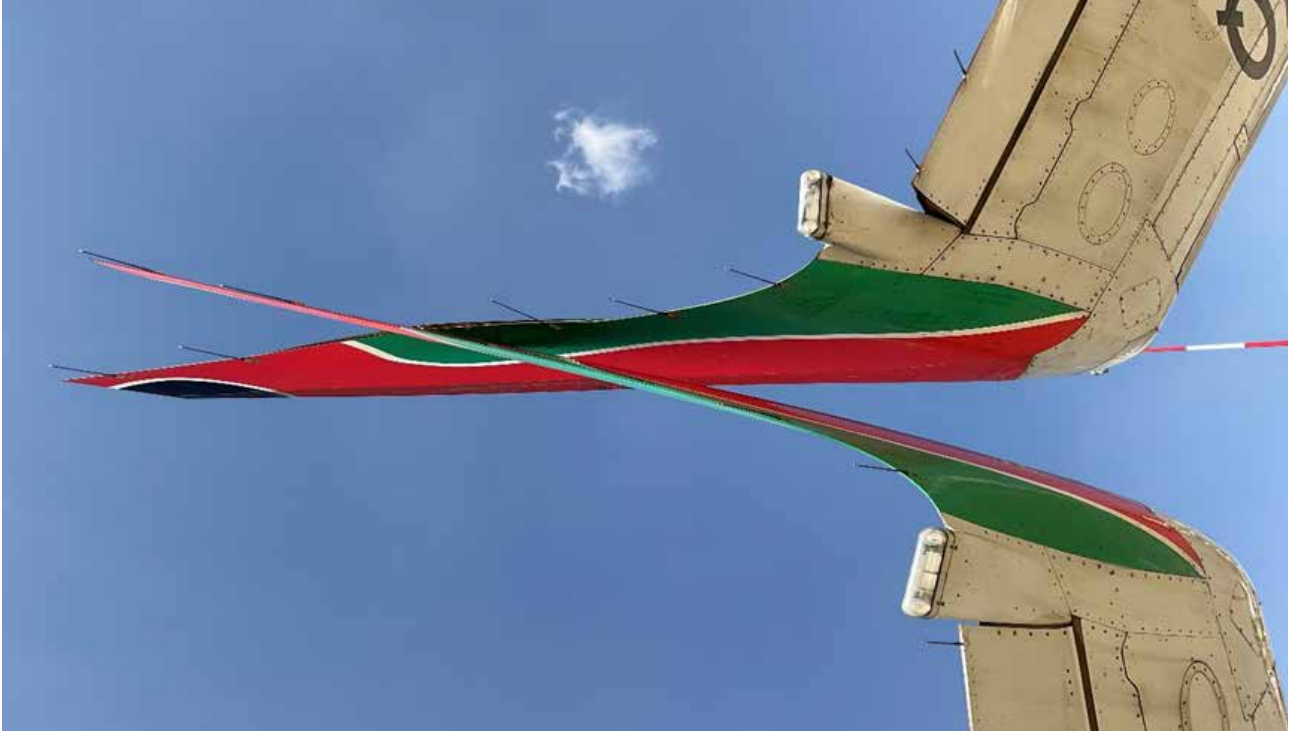
Aircraft registration 5Y-KYQ sustained minor damage to the trailing edge (the aft) of the left-wing tip and one of the static discharges.

**Figure 4:** A photo depicting the minor damage to the left-wing tip of 5Y-KYQ.

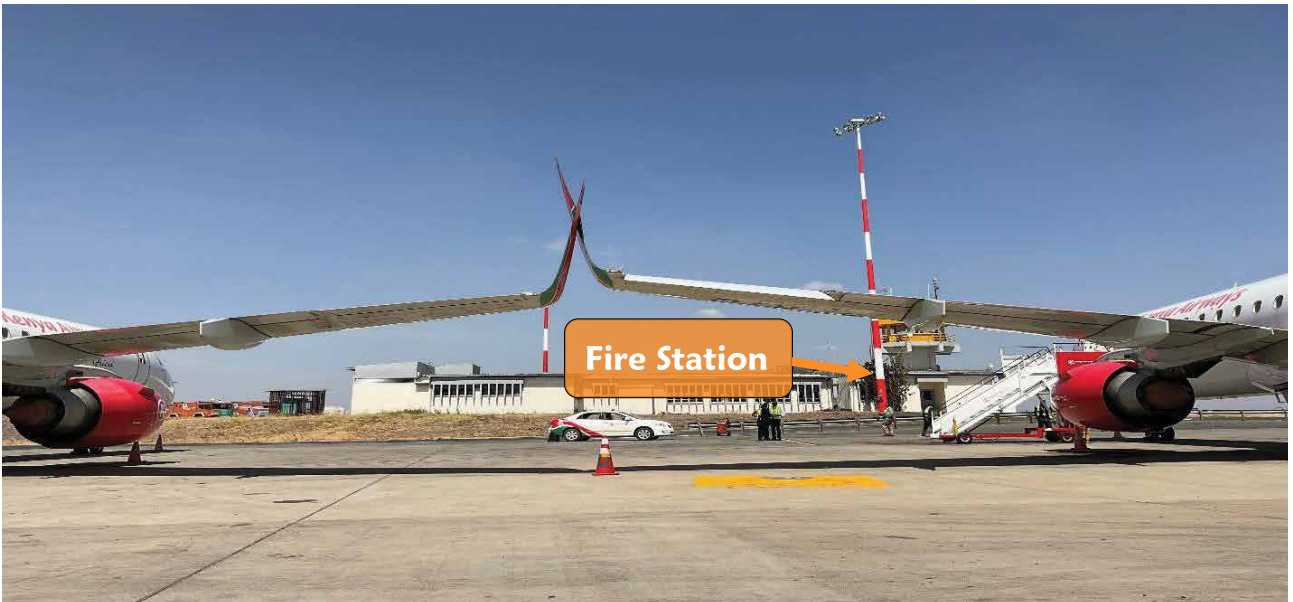
**Figure 5:** A photo depicting the point of contact of the two aircraft and the fire station in the background.

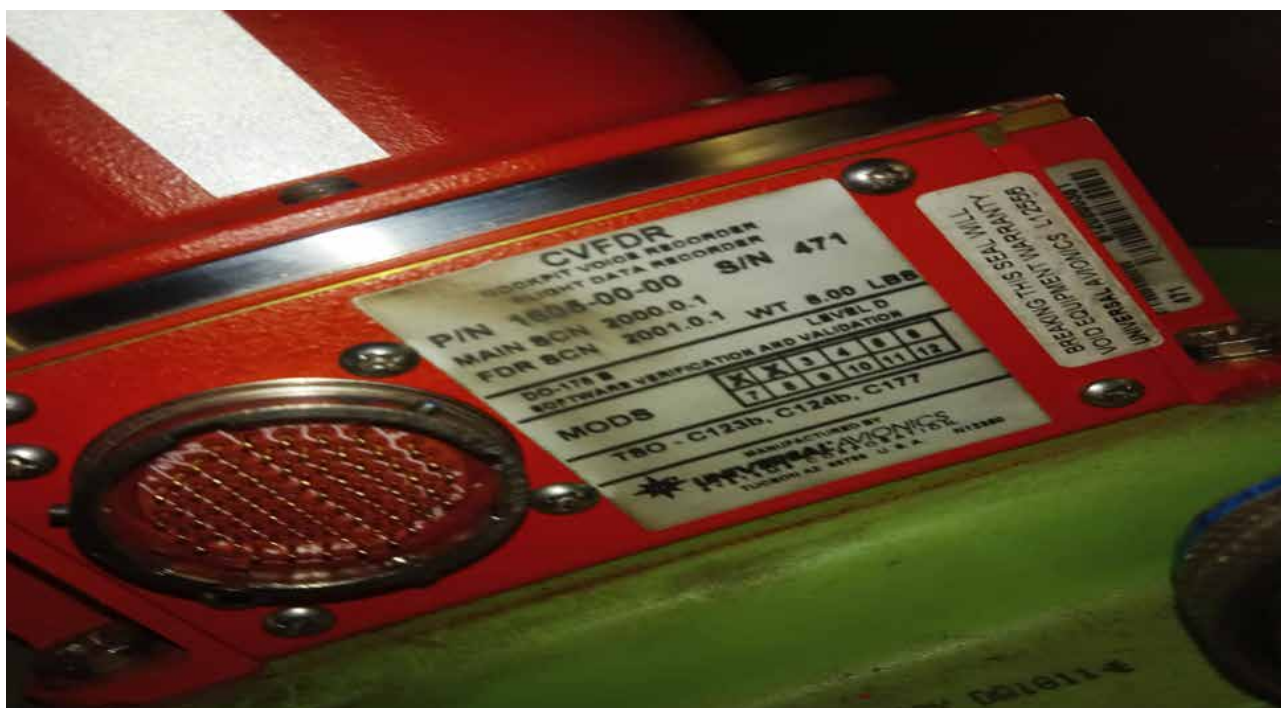
The CVR recording was faint or overwritten.

**Figure 11:** A photo depicting the Cockpit Voice Recorder and Flight Data Recorder
