**INVESTIGATION REPORT No. 03/06/2026**

**A PRELIMINARY INVESTIGATION REPORT OF AN ACCIDENT INVOLVING  
FRA CESSNA 150L REGISTRATION 5Y- ASL, ON 18 JUNE 2026, AT CHYULU  
HILLS, KAJIADO COUNTY, KENYA.**

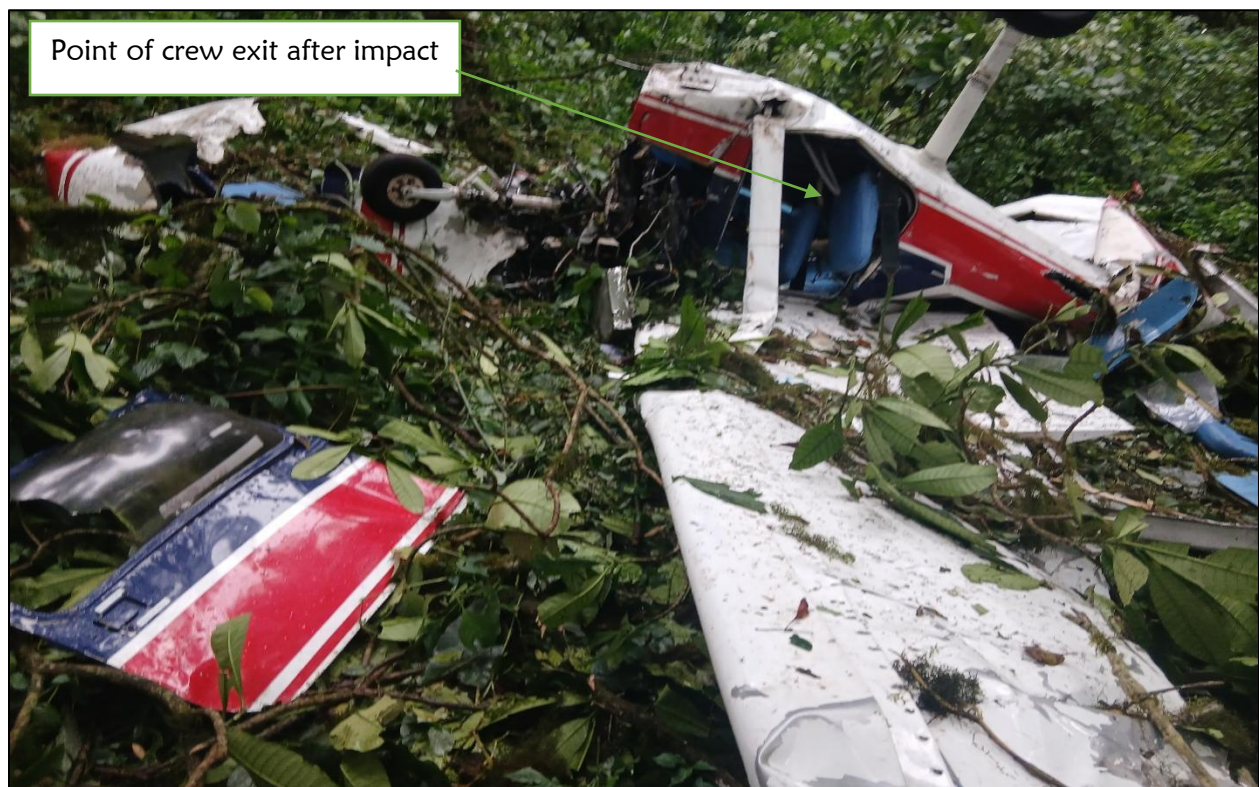
The aircraft collided with trees on the hillside, with the initial impact occurring at coordinates S 02°41'23.1", E 37°53'59.44". The collision subsequently destroyed the aircraft, as illustrated in the photographs below:

**Fig. 2:** *Photograph showing the accident aircraft at the final resting point immediately after impact*

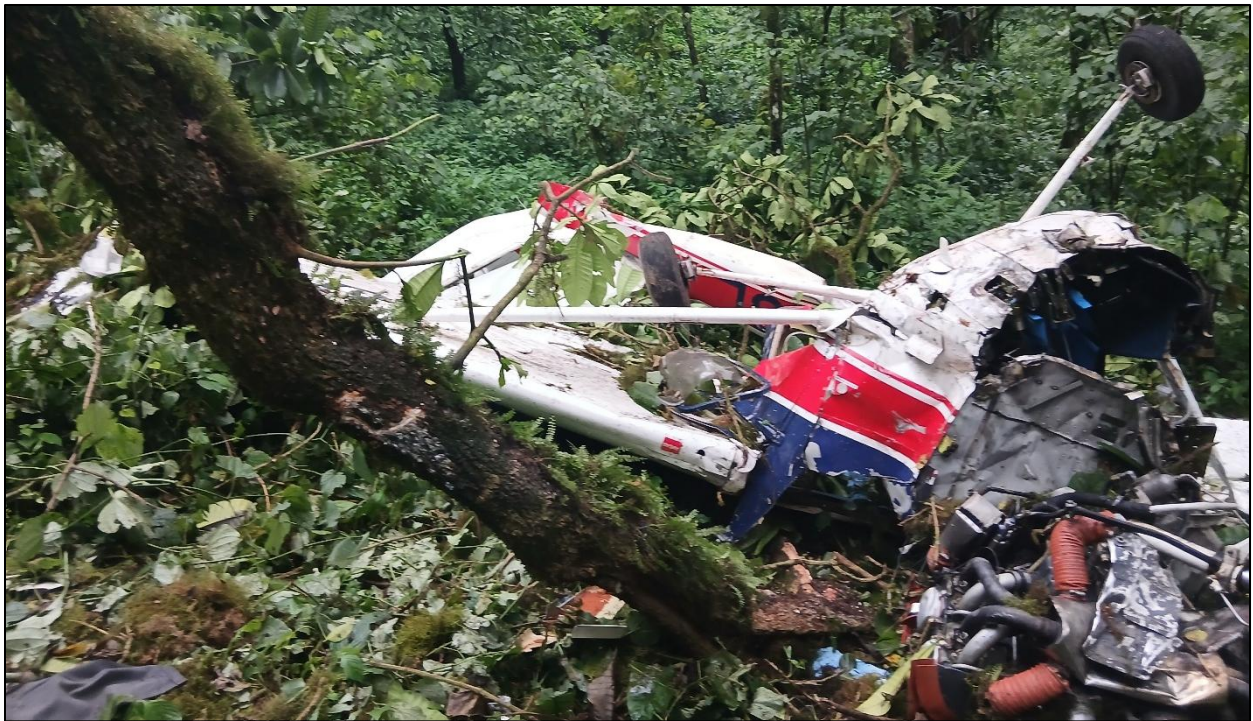
**Fig. 3:** *Photograph showing a tree that broke off and came down with the aircraft on impact*

The occurrence was survivable as the aircraft collided with tree branches that collapsed with it, providing a degree of cushioning and attenuation of the impact forces.

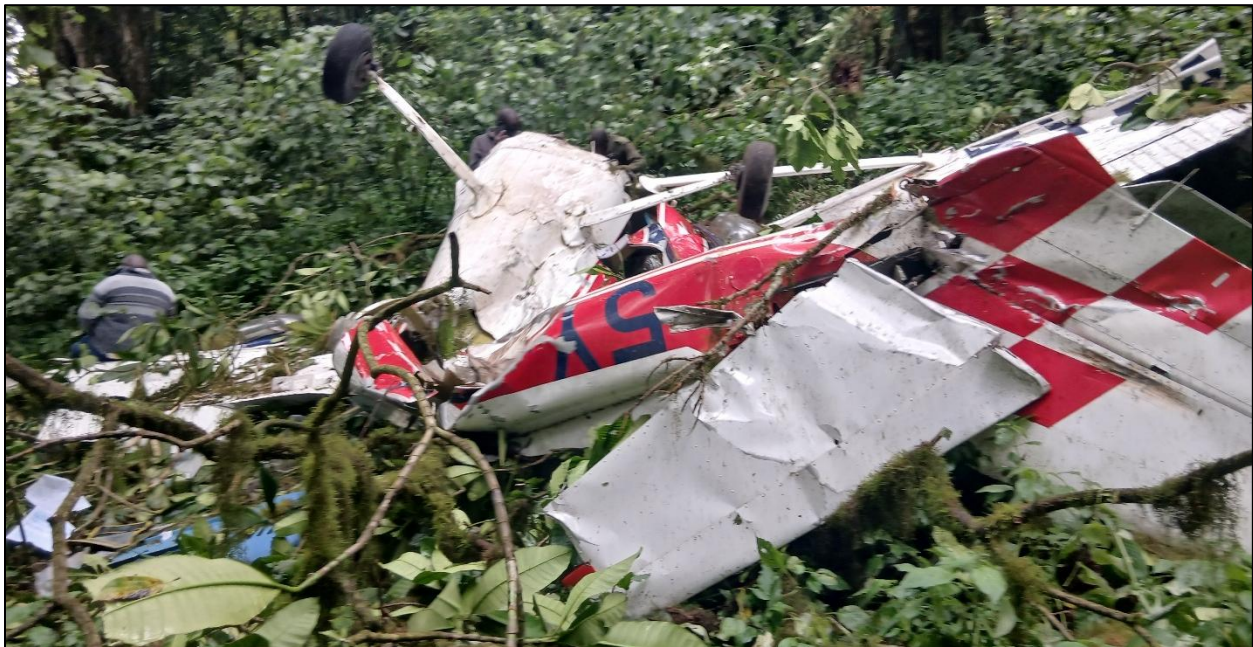
The aircraft was destroyed.

**Fig. 4:** *Photograph showing the extent of damage to the aircraft after impact*

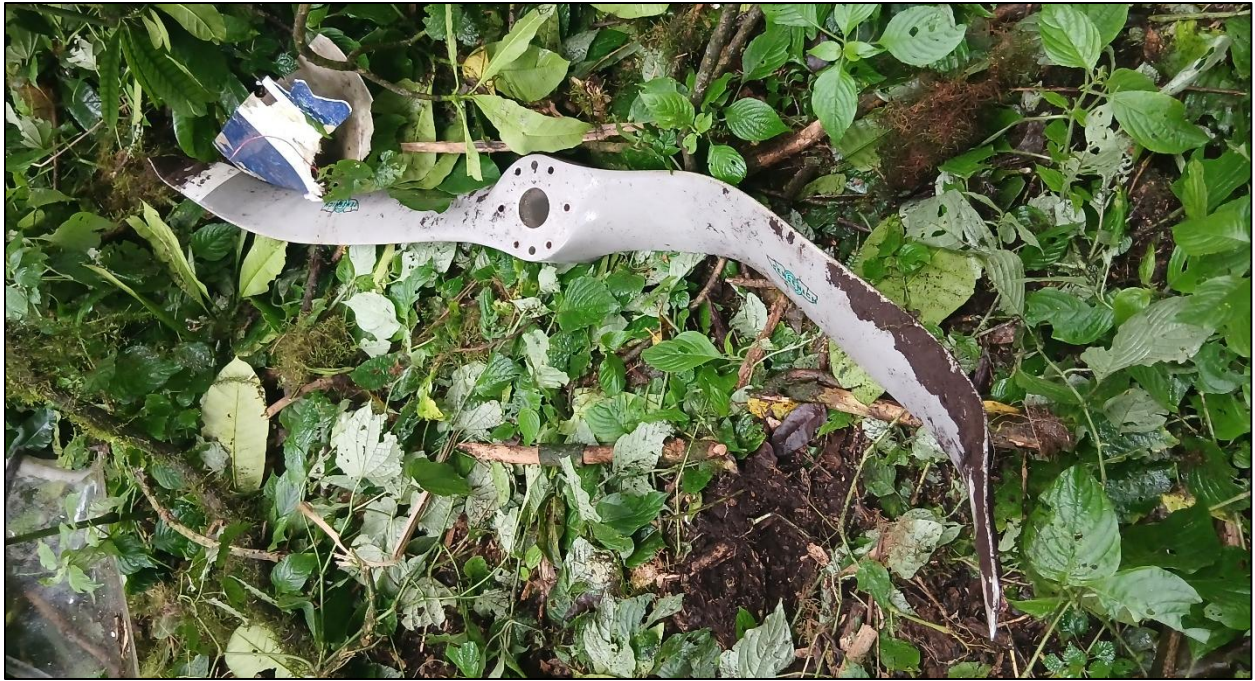
**Fig. 5:** *Photograph showing the propeller blade that separated on impact with the trees*

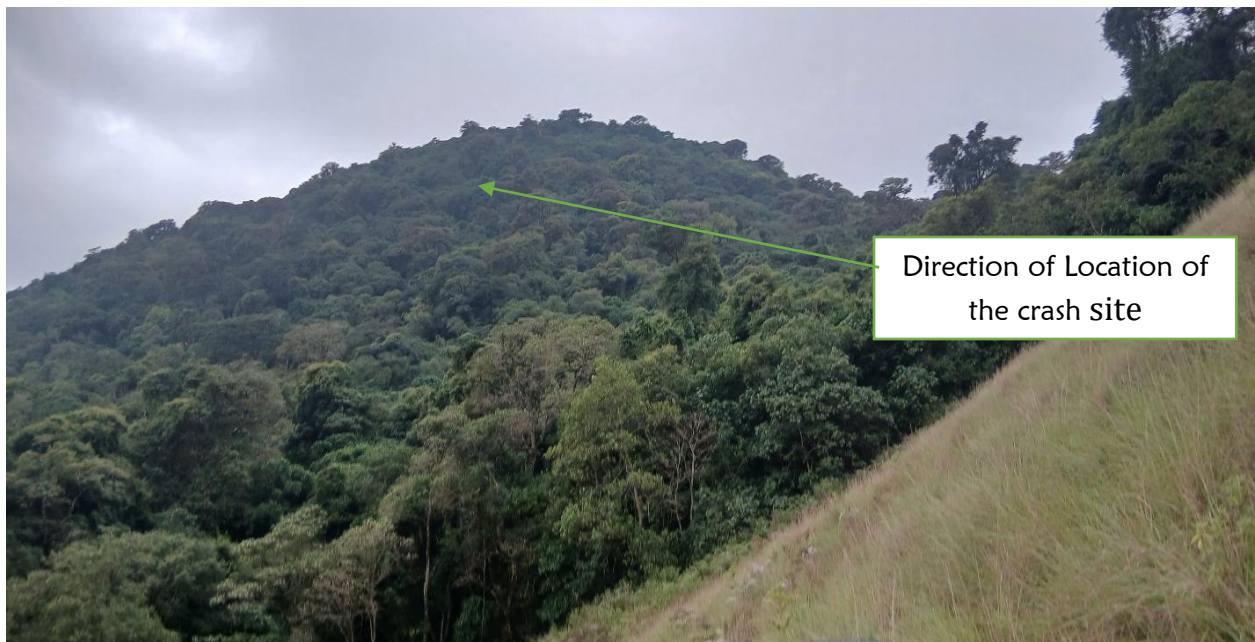
Direction of Location of  
the crash site

**Fig. 6:** *Photograph showing the location of the crash site*
