# INVESTIGATION REPORT

**REPORT No. 01/08/2022**

**FINAL REPORT OF AN ACCIDENT INVOLVING AN  
AIRBUS AS 350 B3E HELICOPTER REGISTRATION  
5Y-CCP ON 04 AUGUST 2022 AT LAKE LOGIPI,  
TURKANA COUNTY**

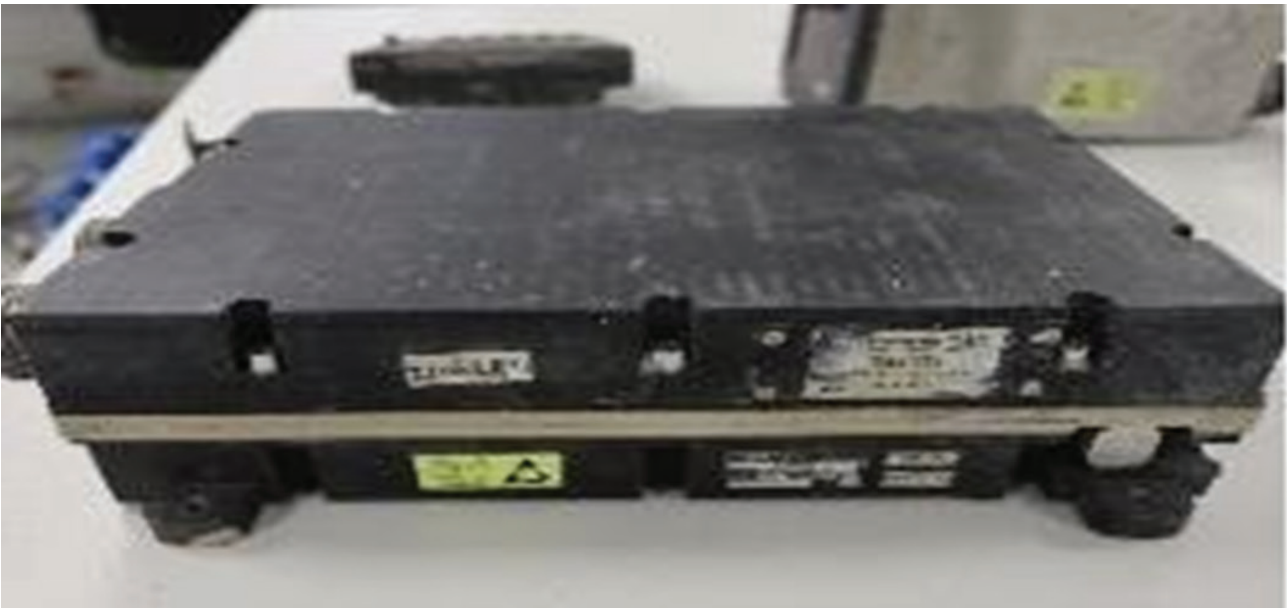
**Figure 6:** A photograph showing the ECU

The Engine Control Unit (ECU) is a dual-module digital control system responsible for fuel regulation, engine parameter management, and engine data recording. During normal operation, engine parameters are recorded at one-second intervals, with the sampling rate increasing to 20 milliseconds for a limited duration when a failure is detected. The EDR dataset includes engine parameters from engine start-up through to the accident sequence. No additional work was carried out on the ECU, as further examination was not expected to provide any additional insight into the cause(s) of the accident.

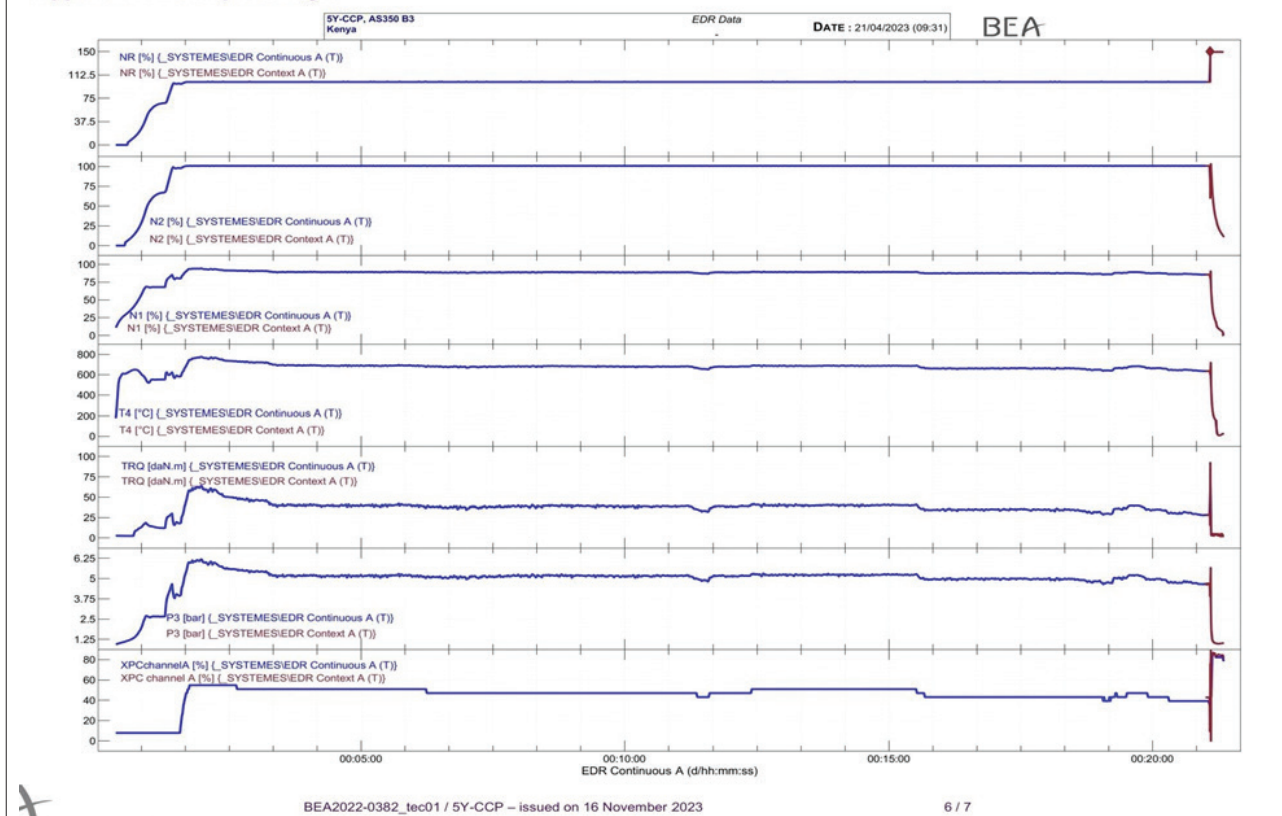
## Appendix 1: Complete flight

Analysis of the available recorded data did not reveal any evidence of engine failure prior to impact. The EDR data showed no anomalies before the helicopter struck the water. All recorded failures and contextual entries were most likely a result of the impact sequence, and no over-limit occurrences were noted during the flight. Technical findings indicate that the flight was uneventful until the moment of impact with the water surface.
