**INVESTIGATION REPORT No. 02/04/2026**

**PRELIMINARY INVESTIGATION REPORT ON A RUNWAY OVERRUN  
INCIDENT INVOLVING AN EMBRAER 120 AIRCRAFT, REGISTRATION 5Y-EBB,  
ON 24 APRIL 2026 AT MANDERA AIRPORT, MANDERA COUNTY, KENYA.**

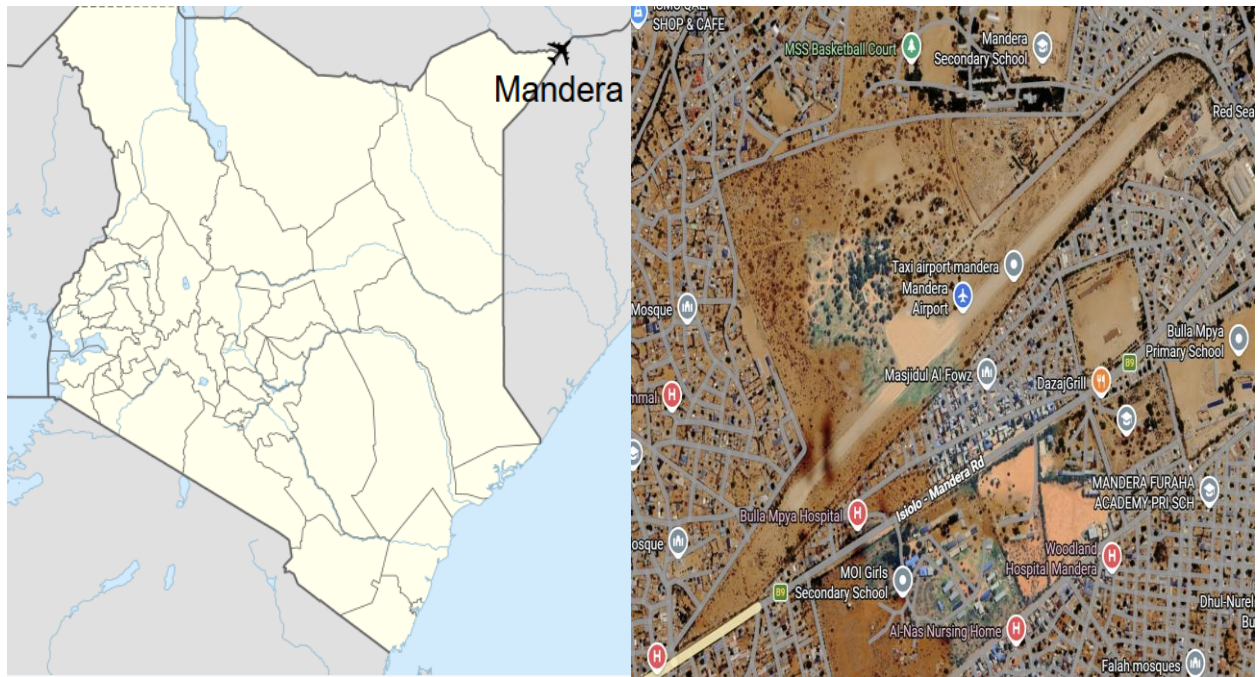
During the on-site investigation, sand contamination was found on the runway surface.

**Fig. No. 11:** Location of Mandera Airport in Kenya (Placement on map is approximate), and aerial view of RWY 05/23 (Source: Google Maps)

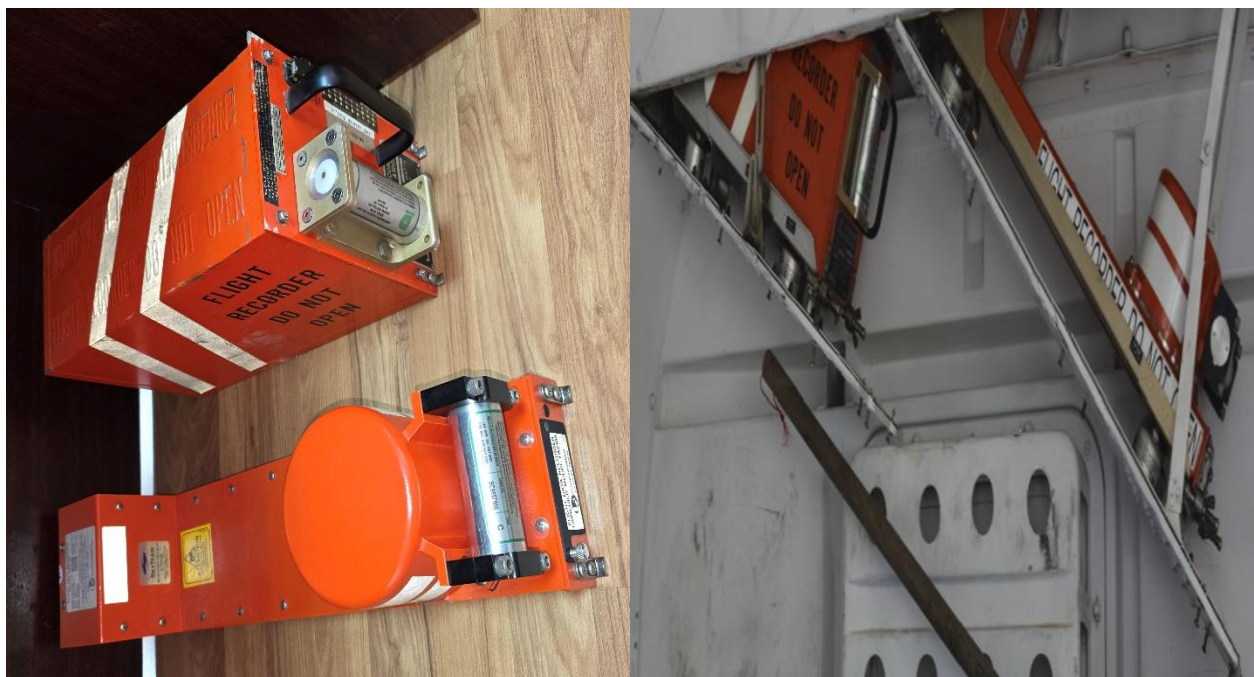
**Fig. No. 12:** Photos of the FDR and CVR

The aircraft was equipped with a Fairchild A100A CVR (Part No. 93-A100-83, Serial No. 61389) featuring a data plate date of 07/93. The CVR was recovered in good condition from the aft section of the aircraft on 25 April 2026. This model of CVR is obsolete and does not conform to the First Schedule of the Civil Aviation (Instruments and Equipment) Regulations, 2018.

The aircraft was equipped with an L3 Communications FA2100 FDR (Part No. 2100-4043-00, Serial No. 000413527), with a manufacturer code (MFR) of 06141 and a manufacture date (DMF) of 09/2006. The FDR was recovered in good condition from the aft section of the aircraft on 25 April 2026.
